THERMAL IMAGING FOR THE EXAMINATION AND CONSERVATION OF CONTEMPORARY MURAL PAINTINGS

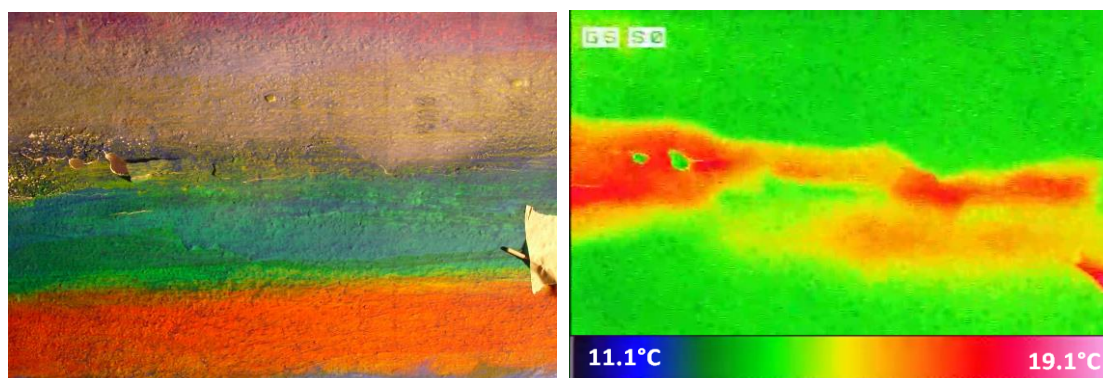
Tarasewicz's vinyl mural paintings: a raking light image of a partially delaminated area and the corresponding thermal map showing the delamination.
