Failure analysis of sandwich-type ceramic-on-ceramic hip joints: A spectroscopic investigation into the role of the polyethylene shell component

Shinya Okita^a, Masahiro Hasegawa^{a,*}, Yasuhito Takahashi^b,
Leonardo Puppulin^b, Akihiro Sudo^a, Giuseppe Pezzotti^b

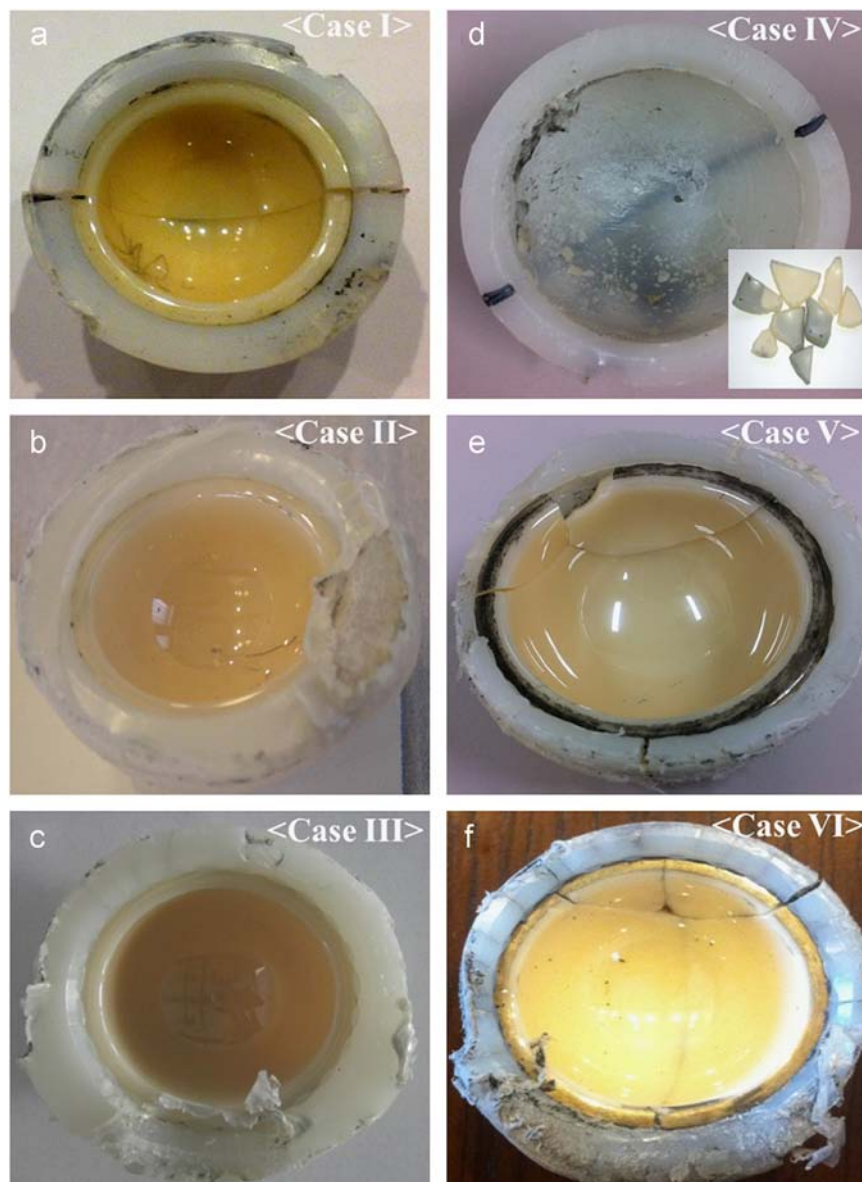
Fig. 3 – Photographs of the ceramic-cup/polyethylene-shell components of the investigated sandwich-type implants after being retrieved from the patients' body. In Case IV, destruction of the ceramic liner occurred *in vivo* (cf. photograph of the ceramic broken pieces in the inset of (d)).

The photographs in Fig. 3(a)–(f) represent the ceramic-cup/polyethylene-shell components of the investigated failed

implants after being retrieved from the patients' body. The results of radiographic examinations immediately before revision surgery are shown for each of the studied Cases in Fig. 4. Case I in Table 1 (Figs. 3 and 4(a)) was revised after dislodgment (namely a clearly visible shift of the joined ceramic/polyethylene parts out of the metal shell). The cause

of failure was simply classified as “dislodgment”, although the retrieval also showed a clear-cut circumferential fracture trajectory dividing the ceramic liner into two distinct parts of about the same size (cf. Fig. 3(a)). The two cases labeled II and III in Table 1 were revised due to liner dislodgment (cf. Fig. 3(b) and (c), respectively, with radiographic analyses in Fig. 4(b) and (c)), and showed no fracture of the ceramic liner. Among the remaining three cases, Case IV showed no visible dislodgment (Figs. 3 and 4(d) for Case IV), but its ceramic liner fractured with extensive fragmentation (cf. photograph of the broken pieces of the ceramic liner in inset of Fig. 3(d)). The many broken ceramic pieces needed to be retrieved separately from the implant in the body of the patient. Cases V and VI both underwent dislodgment (Fig. 3(e) and (f), respectively; radiographs shown in Fig. 4(e) and (f), respectively) and fracture of the respective ceramic liners. However, important differences could be noted in comparing the fracture patterns of the latter two ceramic liners as compared to the other fractured liners. Case V showed three broken (chipped) pieces at the rim of its ceramic liner, but unlike Case I no circumferential fracture path was observed. On the other hand, the fracture pattern in Case IV was somewhat merging the patterns found in Cases I and V, with the display of both edge chipping (into two pieces) and a main circumferential fracture path. The different fracture pattern represents an important difference, which most likely differentiates the mechanisms leading to the catastrophic failure events occurred *in vivo* in different implants, and which will be discussed in forthcoming Section 3.3. In all cases of dislodgment, we never observed any (even local) detachment between the UHMWPE shell and the ceramic liner. Both components thus shifted with remaining integer to each other. Except for Cases I and IV, the polyethylene shells showed significant damages, including severe abrasive wear especially localized at the rim area, in which significant residual deformation also locally occurred, possibly due to creep. In a purely mechanistic view, the damages appeared similar to those reported earlier by Messieh et al. (1994) in describing wear debris originated from the contact of a bipolar cup with the femoral neck. Some circumferential cracks were also visible near the edge of the polyethylene shell belonging to Cases V and VI. Cases II, III, and VI showed severe delamination and flaking of the polymeric structure mainly at the contact area between the shell and stem, but also in other zones around the circumference of the shell. Kaku et al. (2001) described phenomenologically similar microfracture events and damages for the polyethylene liner of a bipolar femoral head. Moreover, our data seem to confirm a thesis put forward by Yamaguchi et al. (2000) in reviewing a large number of acetabular components. These researchers found that cups with impingement were systematically more anteverted than those without impingement. As a matter of fact, we also found significant UHMWPE damage due to impingement in Cases IV and VI, which were the implants with the highest anteversion angle in the studied series of retrievals. Besides promoting subluxation and dislocation of the femoral head, prosthetic impingement was reported to significantly contribute to implant loosening by imparting eccentric loads to the cup and by the direct production of polyethylene wear debris (Coventry, 1985; McCollum and

shell in Case V showed no damage at its rim but it was severely abraded in its backside zone due to impingement on the edge of the metal cup after dislodgment (cf. Fig. 3).

In a recent paper, Dalla Pria et al. (2010) have reviewed the topic of breakage of ceramic-on-ceramic hip couples. Although none of the reviewed implants belonged to the sandwich-type studied here, extensive discussions and classifications were given of fracture patterns in ceramic liners, which present interesting aspects and provide guidance in the context of this paper. Two main types of fracture mode were reviewed: (i) the so-called “undetected fracture” of the liner, in which circumferential fracture occurred into two parts above the conical coupling, with no fragments (Sariali et al., 2009); and, (ii) the rim fragmentation (or chipping) fracture which arises from neck impingement against the rim of the ceramic liner upon subluxation (Ha et al., 2006; Willmann, 2001). The above-referred type (i) of fracture is quite unusual and was not observed in our investigation. In type (ii), even assuming the ceramic liner being correctly positioned in the metal shell, a combination of shocks and edge loading by the ceramic head was designated as responsible for rim breakage, which is indeed what we have observed in Cases V and VI (cf. Fig. 3(e) and (f)). Chipping of the liner has been reported to occur when

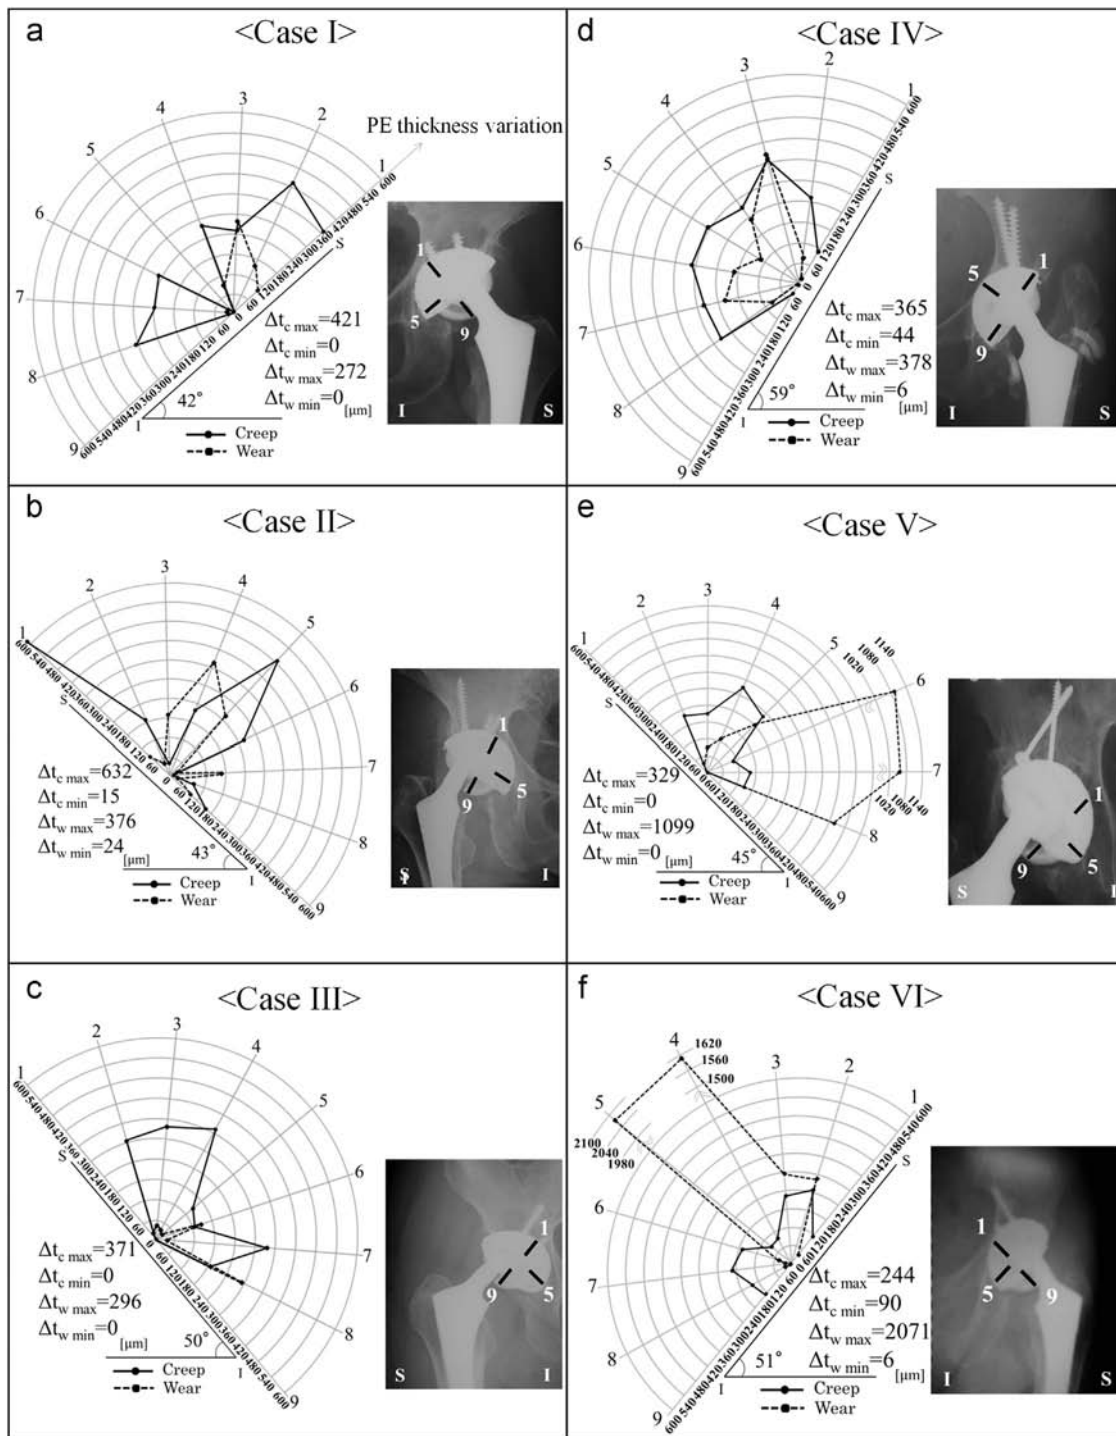
Fig. 4 – Polar plots of the total creep and wear displacements recorded along a circumferential path of the UHMWPE shell of the investigated implants. Inclination angles are also shown for better clarity. Radiographic analyses are shown as collected immediately before revision surgery. The numbers shown in inset of the radiographs correspond to the numbers locating the radial directions in each polar plot.

- (i) In comparing different retrievals, it immediately appears evident that the thickness reductions due to backside wear in Cases V and VI were exceptionally high as compared to the other retrievals examined. However, while in Case VI the maximum wear damage measured ($\Delta t_{w \max} = 2.071$ mm) occurred in correspondence of a location where one would approximately expect the occurrence of the main wear zone, in Case V the maximum wear damage ($\Delta t_{w \max} = 1.099$ mm) occurred at a location corresponding to what one would expect to be the non-wear zone of the cup at the time of implantation. Both implants indeed showed substantial dislodgment, but the difference in the observed locations of wear patterns suggest that, unlike Case VI, abrasive backside wear in the UHMWPE shells of Case V occurred after slip of the UHMWPE shell out of the Ti-alloy shell. This speculation is partly confirmed by the fact that in Case VI significant damage of the UHMWPE shell appeared in the rim area as a consequence of stem impingement during gait (after rotation of the ceramic/UHMWPE components inside the metal shell), while the

- (ii) Both Cases II and III, which by design incorporated the thickest UHMWPE component in their pristine state, showed significant abrasive damage at the rim of the UHMWPE shell (i.e., by impingement of the stem). The *in vivo* times of these two implants were nearly the same and also the longest in the studied series. Both implants showed pronounced dislodgment at the time of revision surgery, but no fracture of the ceramic cup. The occurrence of backside wear was quite limited and localized in both implants, suggesting that dislodgment occurred suddenly. However, peculiar to Case II was a quite high creep displacement at the upper edge of the UHMWPE shell, due to severe impingement by the femoral head at the onset angle for subluxation.

- (iii) Case IV, which showed no dislocation and destruction of the ceramic liner, was the only implant in which creep deformation was quite homogeneous in the polar rotation interval encompassing gait motion (all other implants showed inhomogeneous distributions of creep displacements with maximum values at variable inclination angles). We shall associate the lack of localized deformation in the UHMWPE shell of Case IV to the absence of dislodgment. Despite being the implant with the shortest exposure *in vivo*, the implant of Case IV showed creep displacements comparable with those measured in the long-term retrievals analyzed. This observation confirms the notion that creep deformation in polyethylene hip components mainly occurs during the initial time (<2 yr) from primary surgery (Bewill et al., 2005; Glyn-Jones, 2008).

The results shown in Fig. 4 help visualizing a significant creep contribution to the *in vivo* penetration of ceramic liner component into the Ti-metal shell as a consequence of local flattening of the polyethylene shell. The general conclusion drawn from the examination of Δt_c data in comparison with the overall displacements, Δt , is that, at the time of explantation, the creep flattening contribution in the UHMWPE shell could be locally as large as one third of the entire UHMWPE shell thickness. Such large creep displacements were not only responsible for the linear penetration of the ceramic liner into the metal shell, but also for the successive patient weight redistribution with application of an asymmetric (incorrect) loading to the ceramic liner.

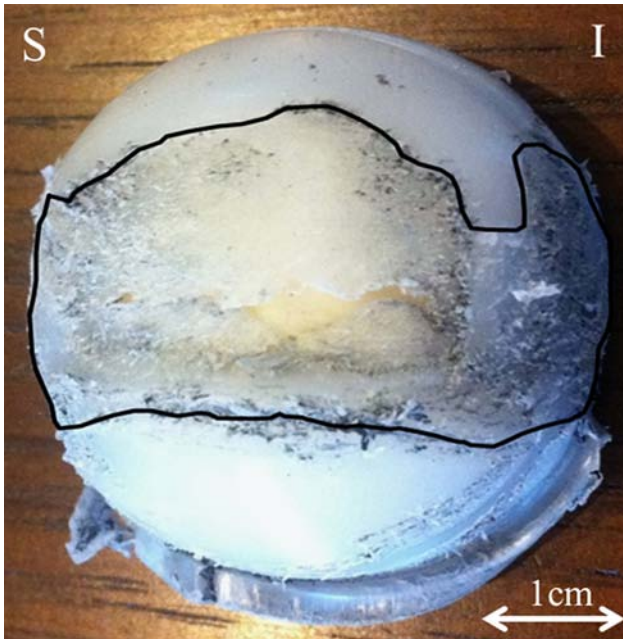
Fig. 5 – Evidence for backside wear in the polyethylene layer of Case V. The abraded area has been highlighted with a black contour for better visualization.

assertion is given in the photograph in Fig. 5. However, it is anticipated at the outset that a comprehensive interpretation of the data shown in Fig. 4 might be quite complex due to the fact that we could only access to final thickness variations, without the knowledge of the temporal sequence at which such variations occurred (i.e., in particular at which stage of dislodgment they occurred). Moreover, different implants showed quite different patterns of creep and wear damages in terms of the respective thickness reductions. Nevertheless, some important evidences could be collected, which can be summarized as follows:

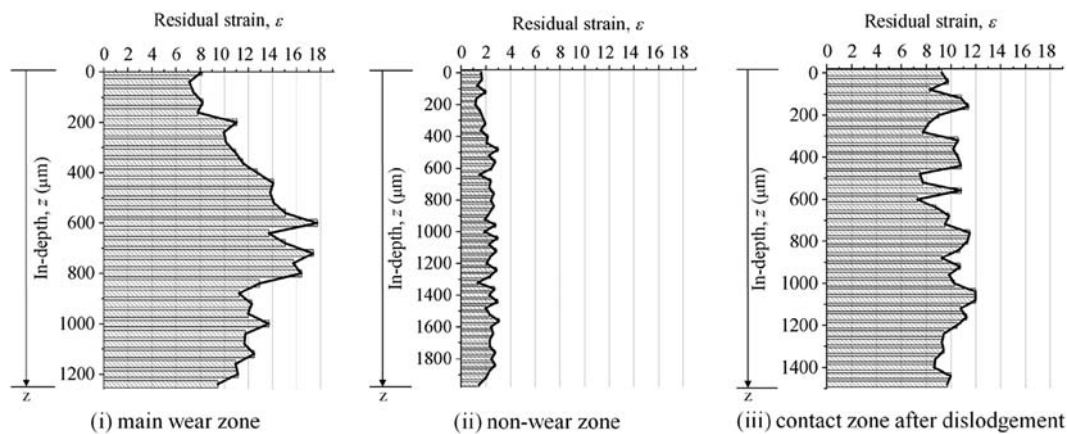
An interesting finding could be obtained by examining the residual strain profiles in Case VI, as developed along the subsurface of the UHMWPE layer of the retrievals. We examined the strain profiles developed at three characteristic zones; namely, the main wear zone, the non-wear zone, and the contact zone after dislodgment (labeled (1), (2), and (3), respectively in the draft of Fig. 2), which corresponded to the angular sectors labeled 3–4, 8–9, and 1–2 in Fig. 2(a), respectively. A low (and conspicuously constant) level of residual strain was found along the thickness, as expected, in the non-wear zone. Moreover, the magnitude of the total

thickness reduction due to residual strain was similar in the main wear zone and in the contact zone after dislodgement (both in the order of the hundreds of μm ; cf. Table 2). However, such thickness reduction arose from residual strain profiles with quite different morphologies. Fig. 6 shows a comparison among the three strain profiles mentioned above. In zone (1), a maximum was found at about 700 μm in the sub-surface, while in zone (3) the strain level was constant along the sub-surface. This interesting detail is in agreement with the previous studies of residual deformation in the polyethylene liner of conventional hip implants (Pezzotti et al., 2011) and suggests that the profile of residual strain piled up during *in vivo* cycling load, namely upon regular deambulation, can be differentiated in the experimental practice from that piled up under abnormal loading conditions (i.e., local impingement after liner dislodgement).

Fig. 6 – Profile of residual strain as detected along the sub-surface of the UHMWPE layer of Case VI in the main wear zone, the non-wear zone, and in the contact zone after dislodgement (labeled zone (1), (2), and (3), respectively, in Fig. 2(a)). Note that the zero point of the in-depth abscissa correspond to the side of the UHMWPE layer in contact with the ceramic liner, as shown in Fig. 2(b).

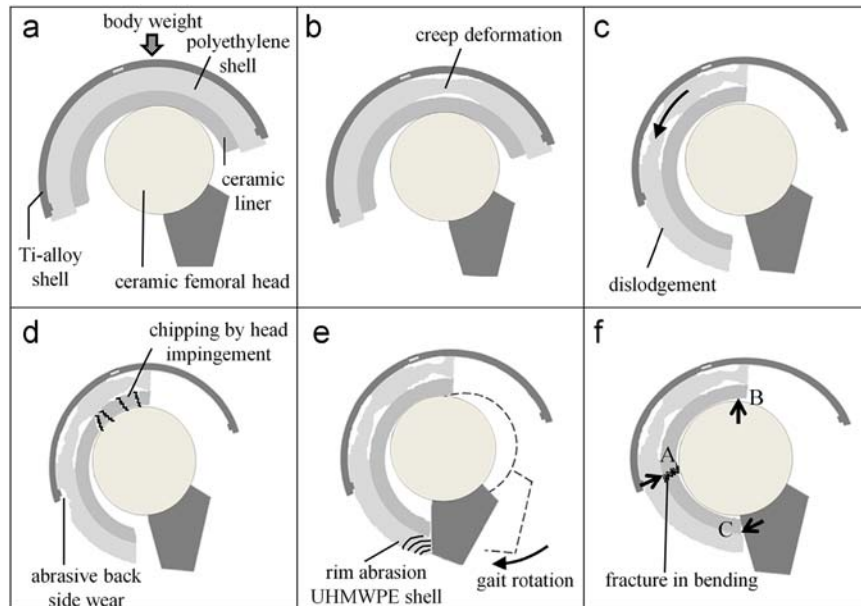
Fig. 7 – Drafts describing the sequence of degradative events that led to the observed liner fracture patterns: (a) sandwich-type hip joint correctly implanted; (b) creep deformation in a limited interval of radial angles of the UHMWPE shell due to body weight; (c) occurrence of dislodgment upon rotation of UHMWPE shell/ceramic liner inside the metal shell; (d) impingement of femoral head on the upper rim of the ceramic liner (i.e., in a state of subluxation) producing chipping of the ceramic liner; (e) impingement of the stem neck on the lower rim of the (rotated) UHMWPE shell, which in turn produced severe abrasions to the shell rim and (f) polar loading (at location A) producing bending of the curved cup component constrained by the supporting points B and C.

(Fig. 7(c)), and such an incorrect implant configuration exacerbated impingements of both femoral head on the upper rim of the ceramic liner (i.e., in a state of subluxation) and stem neck on the lower rim of the UHMWPE shell (cf. Fig. 7(d) and (e)). In addition, Fig. 7(f) schematically shows the state of localized loading on the (rotated) pole of the ceramic cup (integer to the UHMWPE shell). The loading configuration indeed foresees polar loading (at location A in Fig. 7(f)) with bending of the curved cup component upon loading reactions at the supporting points B and C in Fig. 7(f), which corresponded to the rim impingement locations of the femoral head and of the stem neck, respectively. Such loading configuration ultimately led to a single circumferential crack starting from the pole of the ceramic liner and propagating toward the cup base. Experimental evidence supporting the occurrence of such fracture mechanism was searched for on the circumferential fracture surface of the ceramic liner. As shown in Fig. 8, the fracture origin could be found in correspondence of the external surface of the ceramic liner nearby the location where polar pressure was exerted by the metallic shell (location A in Fig. 7(f)).

The complex sequence of mechanisms shown in Fig. 7 can rationally explain the phenomenological observation made on all the analyzed retrievals, with the exception of Case IV. As a matter of fact, the occurrence of multiple crack paths, the observation of no dislodgment in the radiographic pre-operative exam, and the lack of any abrasive damage in the UHMWPE shell clearly reveal the occurrence of a different failure mechanism. The ceramic liner was indeed backed by the thinnest among the UHMWPE shells employed by the maker and the fracture pattern suggests a compressive

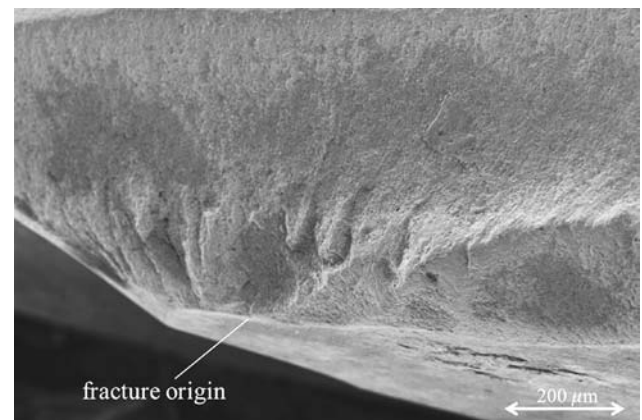
Fig. 8 – Scanning electron micrograph of the fracture origin found on the external side (convex surface) of the fractured surface of the circumferentially broken ceramic liner referred to as Case VI.

fracture event (Espinosa et al., 1998; Zavattieri and Espinosa, 2001), presumably amplified by shocks of the femoral head against the ceramic cup. Recently, Uribe et al. (2011) have presented a focused modeling study of shock-induced damages in ceramic hip prostheses. In this study, the shock-induced stress was determined numerically using finite element analysis and demonstrated that even a minor microseparation effect in an all-ceramic hip implant could cause a severe shock on the bearing surface when the heels touch the ground. Such shock can be as high as nine times the body weight. Owing to the presence of crack initiation sites on

the bearing surface (i.e., as a consequence of wear scars), one could conclude that the thickness of the ceramic liner could have resulted to be too thin to guarantee structural integrity under gait conditions in the presence of microseparation.
