AN AYYUBID SQUARE- PLANNED TOWER AT THE CITADEL OF DAMASCUS: TOWER 8¹

CRISTINA TONGHINI

THIS PAPER WILL DISCUSS the results of a study carried out at the citadel of Damascus in the year 2008 in the framework of a project aimed at the consolidation and rehabilitation of the citadel itself, and promoted jointly by the Directorate General of the Antiquities and Museums of Syria (DGAM) and the Cooperazione Italiana allo Sviluppo (Italian Development Cooperation).² A team led by the University of Parma took part in the main project with a specific programme of analysis and diagnosis of three structures of the citadel (Towers 8 and 12 and the so-called Ayyubid Hall), while developing a scheme for consolidation. A preliminary stratigraphic analysis of these structures was carried out; the results of the analysis presented and discussed here³ are confined to those concerning the north-eastern tower of the citadel, the so-called Tower 8.

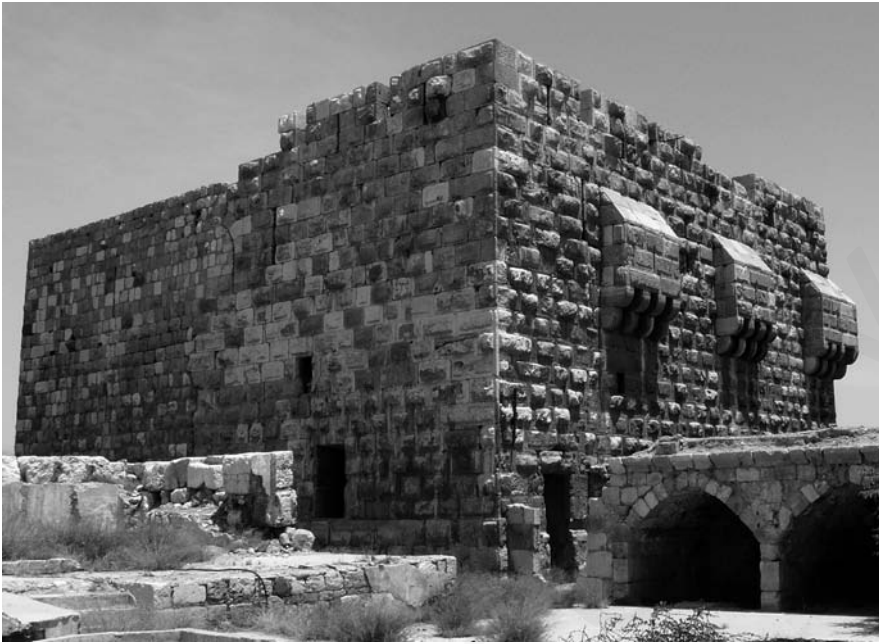
Figure 14.2 *Upper part of tower 8, from the south-west; on the west façade the part on the left corresponds to the reconstruction of Period IV (photograph by C. Tonghini)*

The stratigraphic analysis showed that the tower of Period I had the same plan and four levels as the tower that we see today; modifications have occurred at all levels over time, and the best-preserved portions of the original building can be seen in the southern (Figure 14.2) and south-eastern parts of the tower. Only part of Level 1 preserves the original four boundary walls. In the upper levels major reconstructions can be seen both in the interior and in the exterior; the north-eastern corner of the tower, including the adjacent arrow loops, was rebuilt in Period II and again in Period III (Figures 14.1 and 14.9), whereas the

north-western quarter of the tower was rebuilt in Period IV (Figures 14.2 and 14.9).¹²

For the building of the tower of Period I rusticated stone was used for the external fronts (Figures 14.2, 14.3 and 14.9), while ashlar blocks with flattened surfaces, dressed with a pointed tool and with no margins, were used for the interior (Figure 14.4); more rarely, rusticated blocks also appear in the interior, especially under the level of the floors, where they could not be seen. The original treatment of the joints survives occasionally in the internal masonry. These are of the so-called *rubané* type (Figure 14.5: the mortar shaped to form a kind

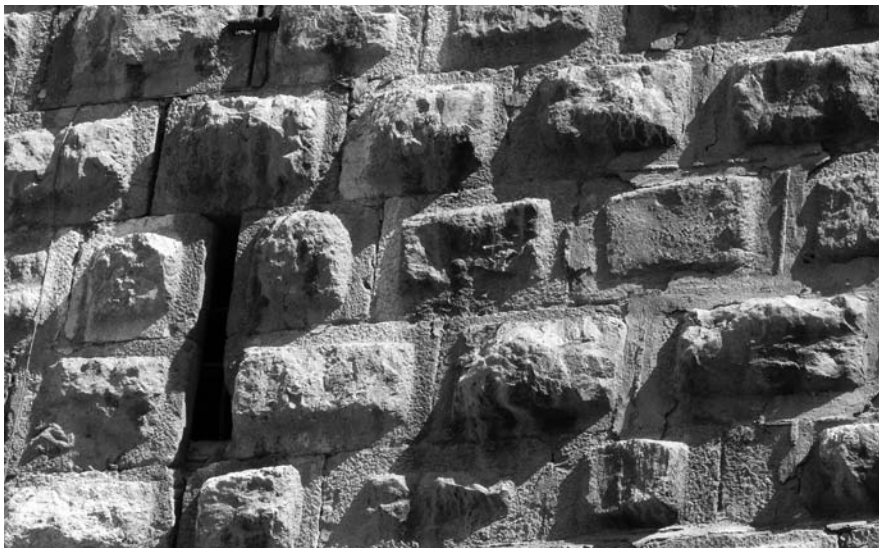
Figure 14.3 (above)
*Southern external wall,
detail; from the south
(photograph by C. Tonghini)*

of projecting band) that appears in other parts of the Ayyubid citadel, such as the so-called Ayyubid Hall, but they may still have been in use in the Mamluk period. Traces of a similar finish were also noted on the external fronts (Period I, southern front: Figure 14.3), but the absence of scaffolding made it impossible to ascertain if these were related to the original bonding or if they belonged to a restoration phase. A partial collapse of an internal wall at Level 2, in niche 11 (Figure 14.1), enabled the masonry to be examined in section: blocks of different depths alternate in order to ensure better bonding to the core; only the sixth face of the ashlar is not worked (quarry faced).

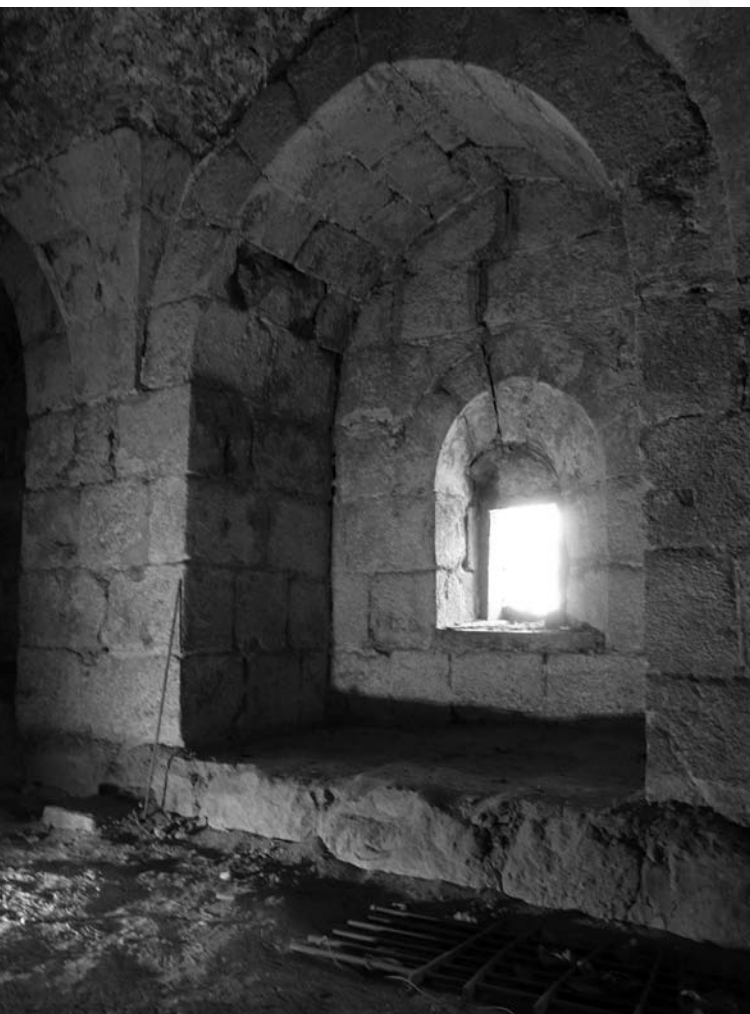
Figure 14.4 (left)
*Level 2, niche 8, from
the west (photograph by
C. Tonghini)*

Figure 14.5 *Level 2, niche 8: the rubané joints (photograph by C. Tonghini)*

All the Period I arrow-loops feature a flat base. The pointed barrel vaults over the niches in the boundary walls are built with ashlars in Period I only (Figure 14.4); most have a keystone, with some exceptions that are difficult to explain at this stage of the research. A system of groin vaults covers the rest of the internal space, resting on brackets that spring from the central pillar and from the pilasters that define the various niches (Figure 14.1). The groin vaults are built with roughly hewn stones of medium size and abundant mortar, with squared stones set in the centre to underline the spine of the cross.

At Level 2 the entire north-western quarter of the tower is the result of the rebuilding that took place in Period IV (Figure 14.1, niches 2–5), while the north-eastern corner (Figure 14.1, niches 6–7) was reconstructed in Period II. Therefore, only niches 1, 8–11 (Figure 14.1) belong to Period I. The vault of the niches of Period I is built in ashlar (Figure 14.4), while all the others are built with rubble and mortar (Figure 14.8).

Niche 8 (Figures 14.1 and 14.4) was analysed in detail in consideration of its relationship with the large dated inscription located on the eastern façade. The evidence is in places still covered with the cement of Period V, but enough of it is exposed to ensure an in-depth examination. On the basis of the analysis of the mortar, the dressing and size of the stones and the way they are laid, this work clearly belongs to the building phase of Period I. Although conducted from a distance, observation of the external portion leads to the same conclusion: the complex stereotomy of the frame (Figure 14.9, US 46) of the inscription makes a perfect match with the abutment wall south of it and the jamb of the arrow-loop of niche 8 (Figures 14.1, 14.7 and 14.9, US 45). In other words, the perfect bonding and fitting of all the various parts clearly indicate that the building of niche 8 and its arrow-slit (US 45, Figure 14.7) is contemporary with the installation of the frame (US 46) of the inscription. The rebuilding that occurred in Period II abuts the northern edge of the frame of the inscription (Figure 14.9, US 39, 40).

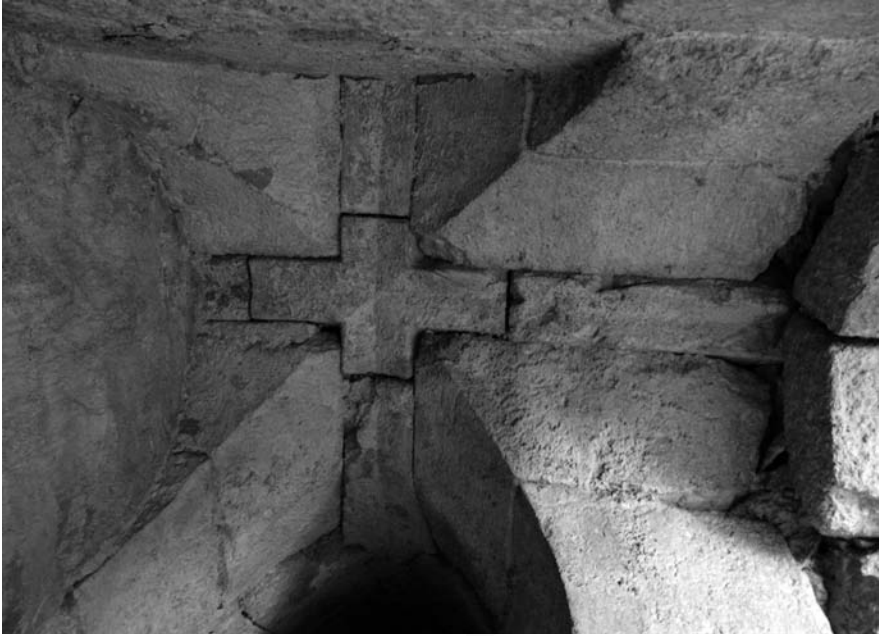
Figure 14.6 *The vaulting of the staircase (photograph by C. Tonghini)*

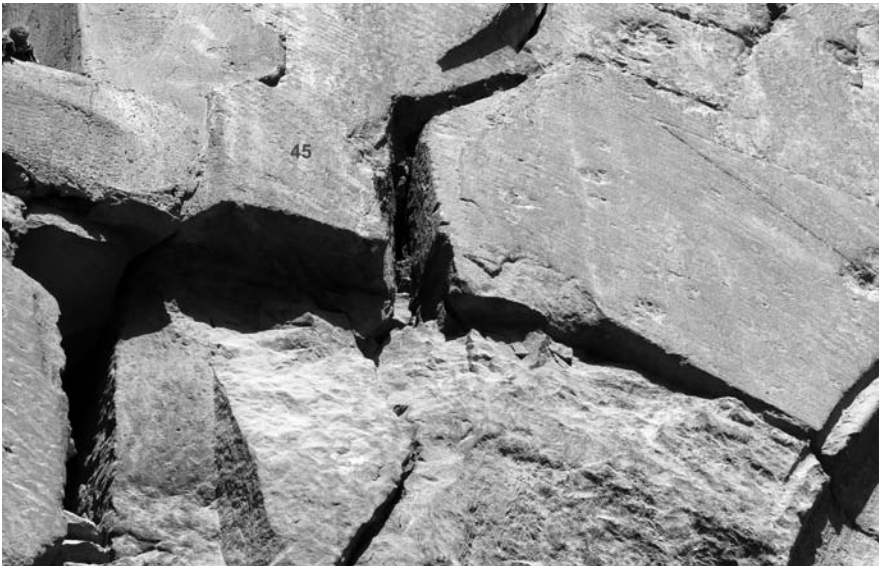
Figure 14.7 *Eastern external wall; detail of the jamb of niche 8, US 45; see Figure 14.9 (photograph by C. Tonghini)*

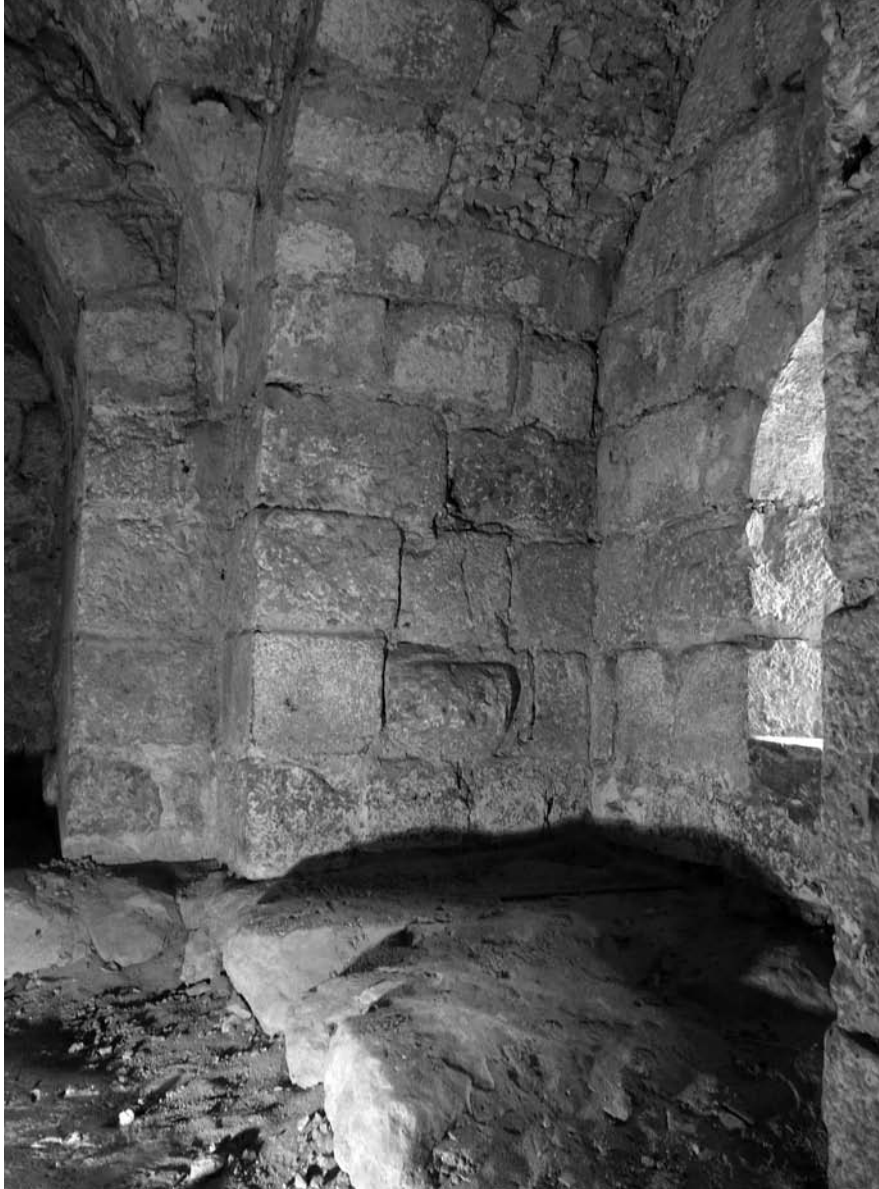
Figure 14.8 Level 2, niche 7, from the south west (photograph by C. Tonghini)

There is an important difference in construction technique in the niches of Level 2: the arch is in ashlar but for the vault rubble and mortar are used instead of the ashlar blocks that characterise the vaults of the Period I niches (Figure 14.8).
