Youth in Conservation of Cultural Heritage, YOCOCU 2012

## Stucco Forte in Venice between the 16<sup>th</sup> and 17<sup>th</sup> centuries: the case study of Addolorata Chapel stuccoes in San Pantalon's Church

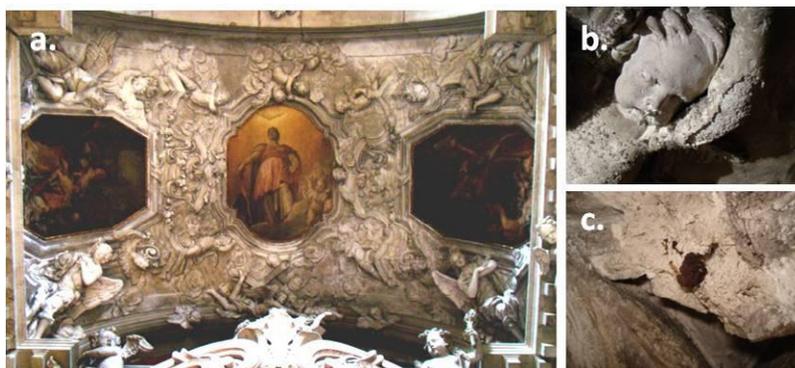
The conservation state of the stuccoes was in general bad, but non critical (Fig. 1). Disaggregation of the surfaces and presence of salt efflorescences were the major degradation processes. The salt efflorescences created in many case thick and hard crusts that could be hardly separated without damaging the stucco surfaces. The presence of sub-efflorescences were also observed in many areas leading to the detachment and exfoliation of the surfaces. Moreover, detachments of bigger portion of material were observed revealing in many areas the underneath iron rods composing the skeleton of the structure. During this first phase, it was also possible to distinguish many interventions related to previous restorations, recognizable because a brighter and paler stuccoes was applied.

Fig. 1 (a) Vault of the Addolorata Chapel in San Pantalon's Church; (b) material losses and spalling (c) detachment and rusty iron rods

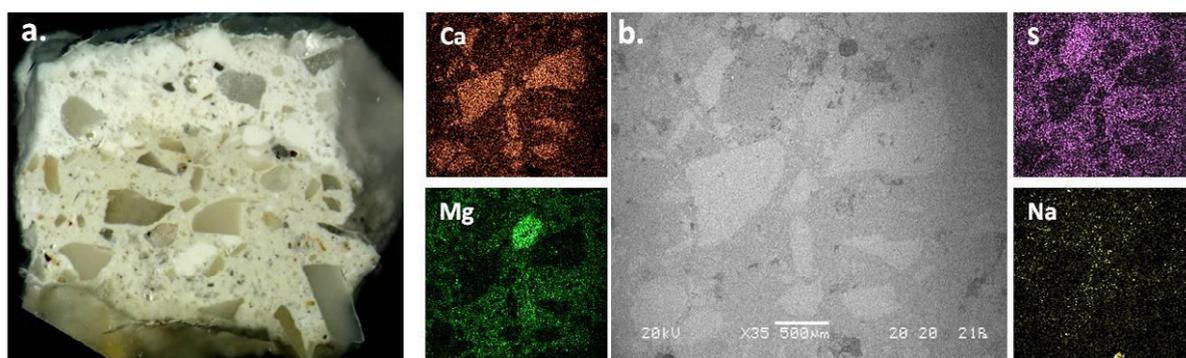
Figure 2 shows the cross section of one of the collected samples presented here as an example. Two layers, different for color and structure, can be identified. The inner one, identified as the bulk material, is a dark- grey

stucco with a granulometric distribution (Table 1) of the aggregates in the range of 0,09-2 mm and an average diameter around 0,18 and 0,71 mm. The external or finishing layer is composed of a brighter stucco with aggregates dimension that ranges from 0,09 to 0,18 mm, and average diameter around 0,18mm. In both cases, the binder presents a pale color and is characterized by a microcrystalline texture and homogeneous structure, while the aggregates differ in color and shapes. The aggregates of the bulk are in fact darker, bigger and coarser than the one of the surface-layer with a binder aggregate ratio (B/A) higher for the finishing layer. A higher amount of binder respect to the aggregates allows to obtain a finer and more workable mixture.

Fig. 2 (a) Smoothed cross section of sample C15B observed at optical microscope 16X; (b) SEM image of the bulk 35X and EDX elemental maps of calcium, magnesium, sulphur and sodium

SEM-EDX observations provided the qualitative elemental analysis of the samples (Fig. 2). Calcium, sulphur, silicon, and aluminum together with sodium, chlorine and magnesium were detected as mayor elements. Calcium and sulphur show a strong signal in all the samples. However, from the elemental mapping the presence of sulphur was detected only in the binder, while calcium was found in the binder as well as in the aggregates, suggesting that marble powder might have been used as main aggregate. Magnesium was also found in some aggregates and in minor traces in the binder. Silicon and aluminum were also detected in some aggregates of the bulk stuccoes and are probably related to the addition of sand in the stucco mixture. Sodium and chloride were

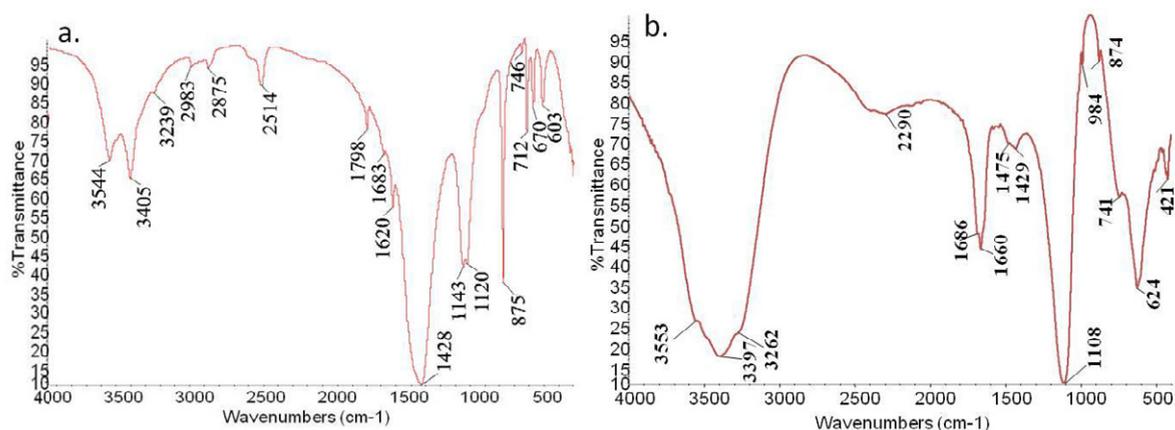
Figure 3 (a) shows one of the spectra obtained via FTIR of the samples bulk. The S-O stretching peak at  $1143\text{ cm}^{-1}$  and the  $-\text{SO}_4$  bending peaks at  $603\text{ cm}^{-1}$  and  $670\text{ cm}^{-1}$  confirm the presence of gypsum as binder both in the finishing layer and in the bulk. Calcium carbonate was also found in all the analyzed samples (stretching peaks of  $-\text{C}=\text{O}$  at  $1798\text{ cm}^{-1}$  and  $1428\text{ cm}^{-1}$ ; bending peaks at  $875\text{ cm}^{-1}$  and  $712\text{ cm}^{-1}$ ). The presence of magnesite ( $\text{MgCO}_3$ ) was also suggested by a peak at  $746\text{ cm}^{-1}$ , which is the unique peak that differs calcium carbonate from magnesium carbonate [1].

The FTIR analysis of the salt efflorescence products (Fig. 3b) highlights the presence of epsomite ( $\text{MgSO}_4 \cdot 7\text{H}_2\text{O}$ ) identified by the peaks at  $1108\text{ cm}^{-1}$ ,  $624\text{ cm}^{-1}$  and  $741\text{ cm}^{-1}$  related to the presence of sulphate groups, and the intense and broad  $-\text{OH}$  peak at about  $3300\text{ cm}^{-1}$ .

Fig. 3 FTIR analysis (a) bulk sample (b) salt efflorescence

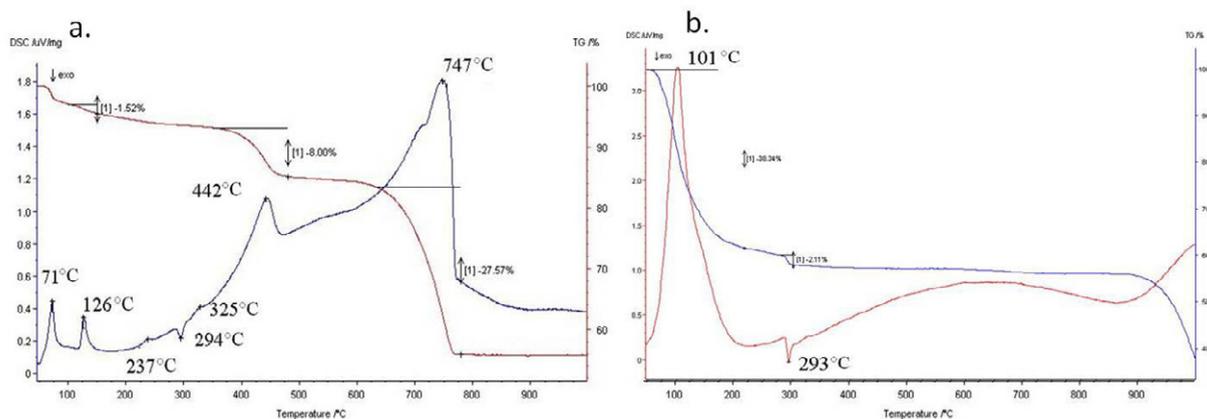
The TG-DSC analysis of the bulk samples confirmed the presence of gypsum and calcium carbonate, recognizable as mass losses between  $100\text{--}150\text{ }^{\circ}\text{C}$  and  $630\text{--}780\text{ }^{\circ}\text{C}$ , respectively. The lower temperature detected for the transformation of calcium carbonate to calcium oxide, usually at about  $700\text{--}800\text{ }^{\circ}\text{C}$  [10-12] might be related to a partial or incomplete crystallization of the lime added to the stucco as binder. A third mass loss was detected at about  $350\text{--}480\text{ }^{\circ}\text{C}$  in correspondence to an endothermic DSC peak, which can be related to the transformation of magnesium carbonate to magnesium oxide [1]. The thermogram of the finishing layer (Fig. 4 (a)) shows again the mass losses of gypsum ( $100\text{--}150\text{ }^{\circ}\text{C}$ ), magnesite ( $350\text{--}480\text{ }^{\circ}\text{C}$ ), and calcium carbonate ( $630\text{--}780\text{ }^{\circ}\text{C}$ ). Three other small peaks were detected in the DSC analysis: an exothermic peak at about  $294\text{ }^{\circ}\text{C}$  related to the presence of epsomite and two endothermic peaks at  $237\text{ }^{\circ}\text{C}$  and  $325\text{ }^{\circ}\text{C}$ . The endothermic peaks are indicative of the dehydration of hydromagnesite and of the decomposition of the carbonate and hydrate, respectively [13; 14].

The TG-DSC analysis of sample collected from an efflorescence was also performed (Fig. 4 (b)) for the identification of the degradation compounds. A first strong mass loss was detected between  $50\text{--}200\text{ }^{\circ}\text{C}$  with a correspondent DSC endothermic peak centered at  $101\text{ }^{\circ}\text{C}$ , which can be related to the dehydration reaction of epsomite and the formation of  $\text{MgSO}_4 \cdot 0,1\text{H}_2\text{O}$  [15]. A second mass loss, correspondent to an exothermic DSC peak, was also found at about  $290\text{ }^{\circ}\text{C}$  and it is probably related to the transformation of amorphous  $\text{MgSO}_4 \cdot 0,1\text{H}_2\text{O}$  to crystalline  $\text{MgSO}_4$  [15]. The reactions involved in the process can be schematized as follows:

Fig. 4 TG-DSC analysis: (a) sample 4 from the finishing layer; (b) sample S1 salt efflorescence
