SVETI PAVAO SHIPWRECK

A 16th Century Venetian Merchantman
from Mljet, Croatia

Carlo Beltrame, Sauro Gelichi and Igor Miholjek

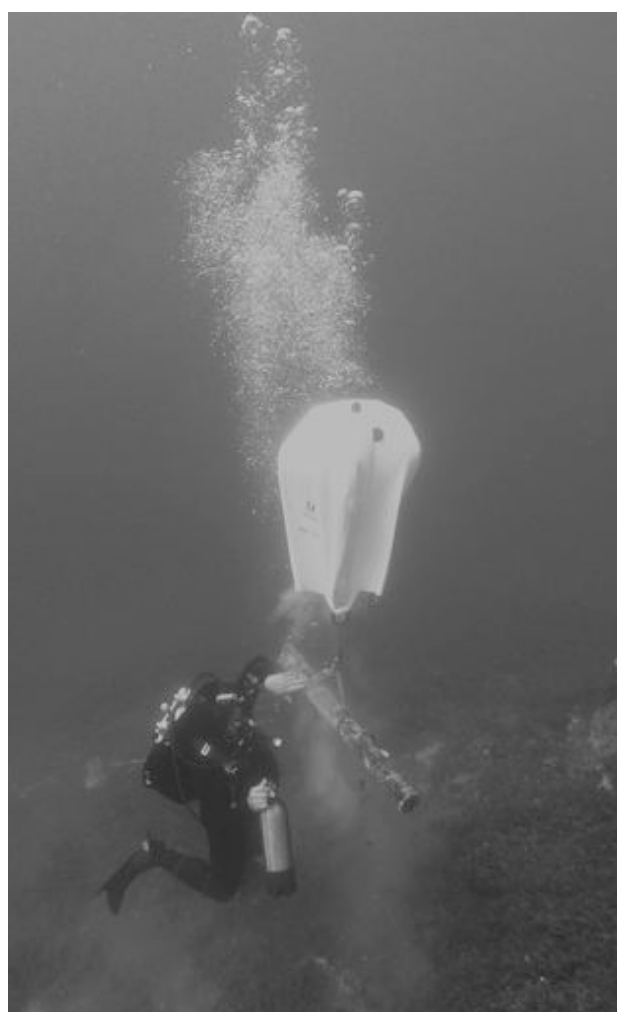
Fig. 2.2. Raising of one of the artillery pieces using an air lift (photo: I. Miholjek, HRZ archive)

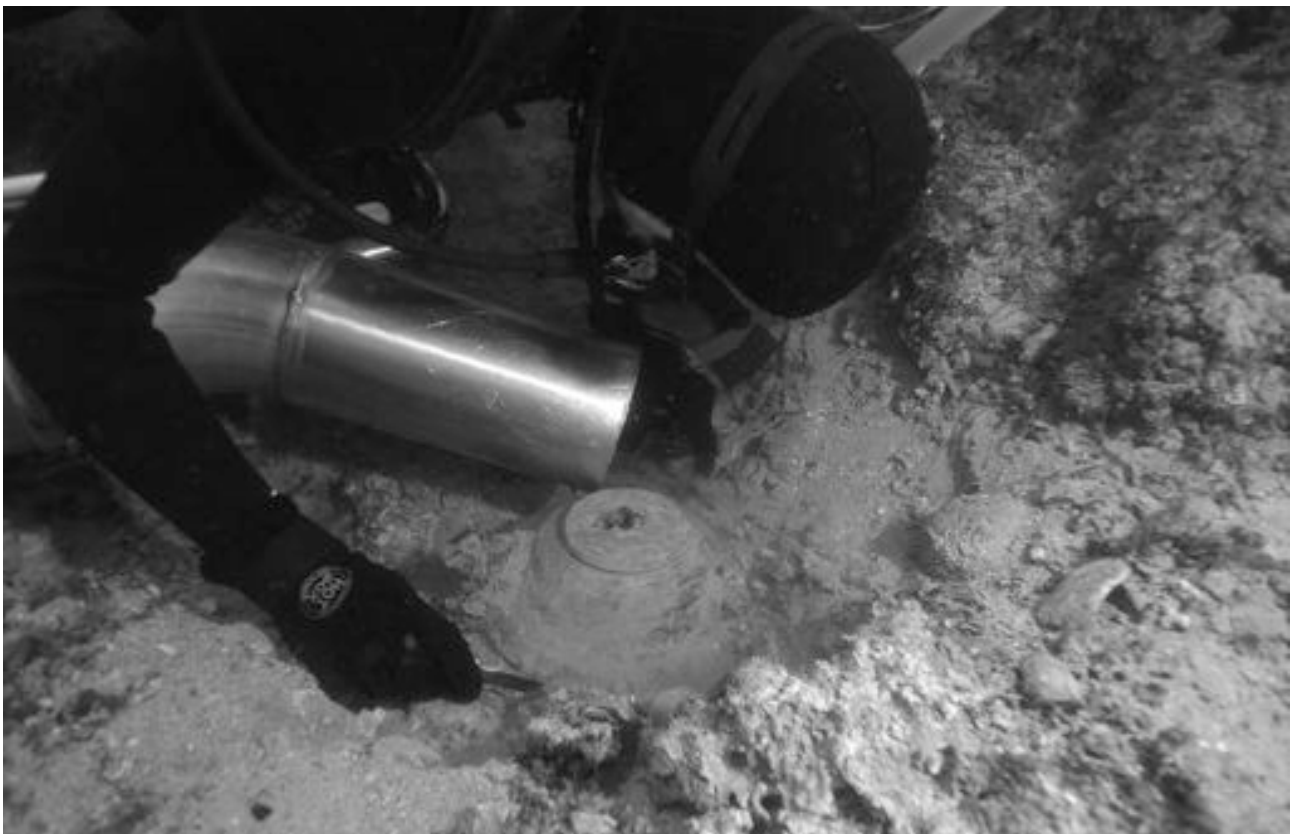
Fig. 2.8. Excavation was conducted using a water dredge (photo: I. Miholjek, HRZ archive)

12 archaeological trenches (Fig. 2.7). They were designated A–L and enclosed part of the research area from 2007. Archaeological trenches were excavated using a water dredge (Fig. 2.8). During this research phase 51 objects were documented and recovered up to the surface. Nine stone shot made of limestone were found (Fig. 2.9). One small lead shot was found inside the sand layer on the bottom of the trench. This shows the ship was armed not only with artillery pieces but also with arquebuses. Metal objects were also found on the sea bottom, including a copper food warmer with a horizontally hammered band in relief below the rim. Other items include a bronze, convex plate for a scale with three small holes used for hanging, with a diameter of 6.2 cm; a lock cartridge measuring 14×6 cm; a glass bead of diameter f 10 mm and a large number of animal bones. An iron anchor found at a depth of 37 m and 25 m to the north of Sector 1 (area with the highest concentration of finds, Plan 2) was also documented and named Sector 3 (Plan 1). It is 2.20 m long with the tilt on top having a diameter of 60 cm, The lower part of the anchor was buried in the sand and only one arm was barely seen protruding. Taking into consideration the site was found intact, it was necessary to preserve the conditions of the preserved ship's hull during all underwater investigations (digging, documentation etc) Therefore, additional care was given to the hull, paying special attention to the documentation of the wooden remains in order to get a better image of the ship itself, its function and details about the unfortunate capsizing of the vessel. The 2008 campaign lasted for six days during which 54 immersions

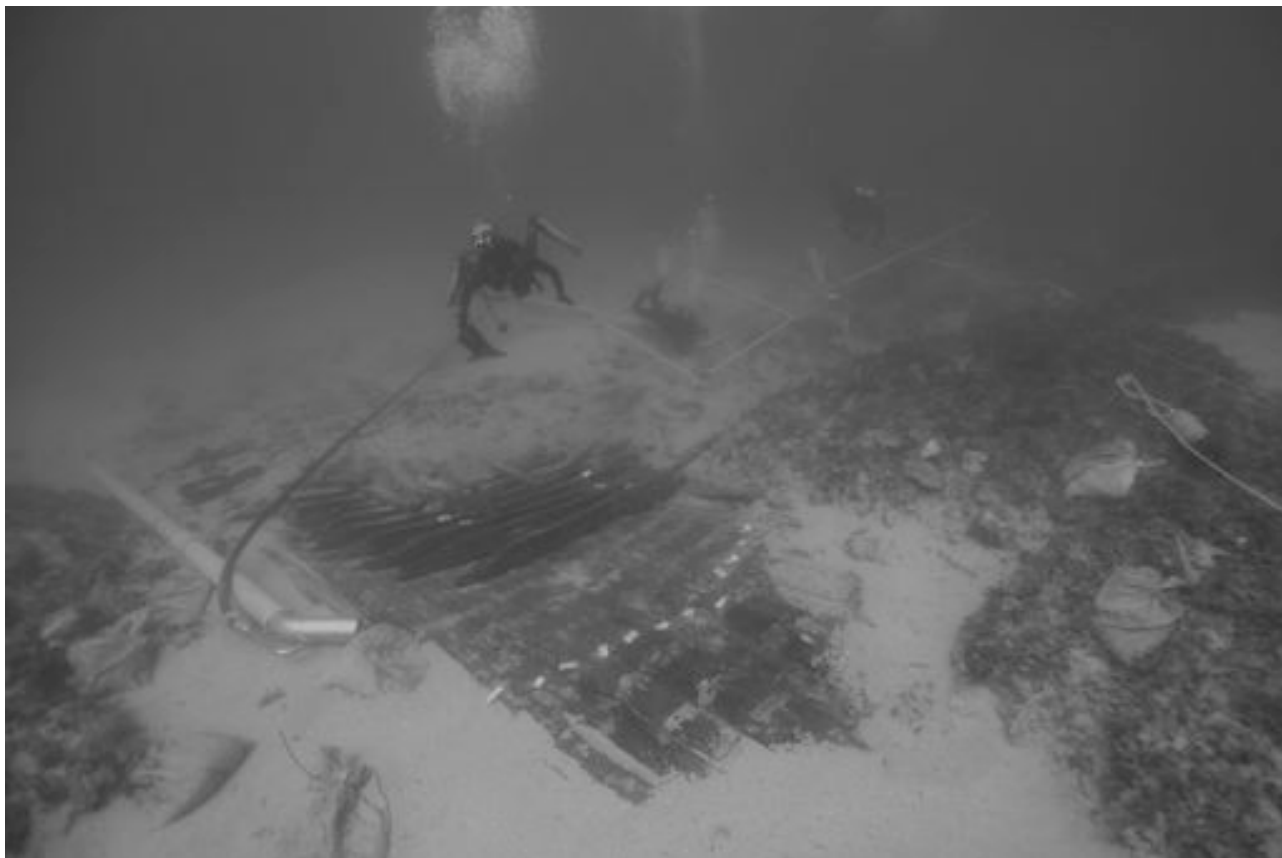
Fig. 2.13. The view of the site – Sector 2 and the remains of the ship's hull and Sector 1 with the ship's cargo (photo: I. Miholjek, HRZ archive)

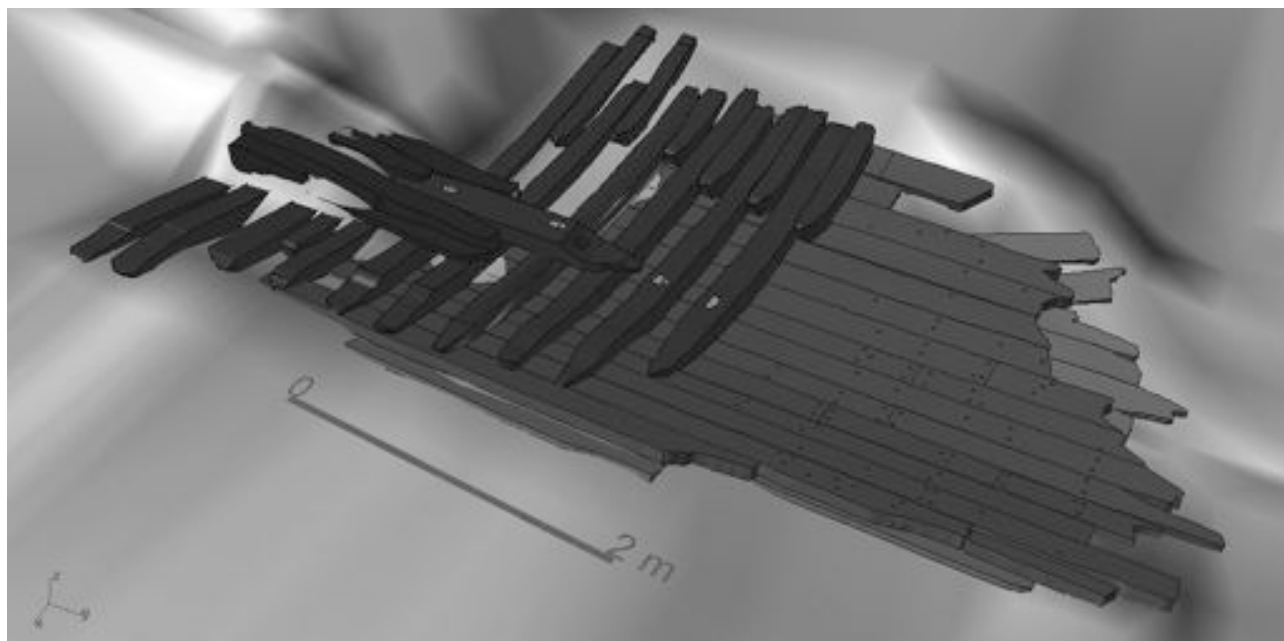
Fig. 2.17. 3-D reconstruction with Rhinoceros software (drawing: E. Costa)

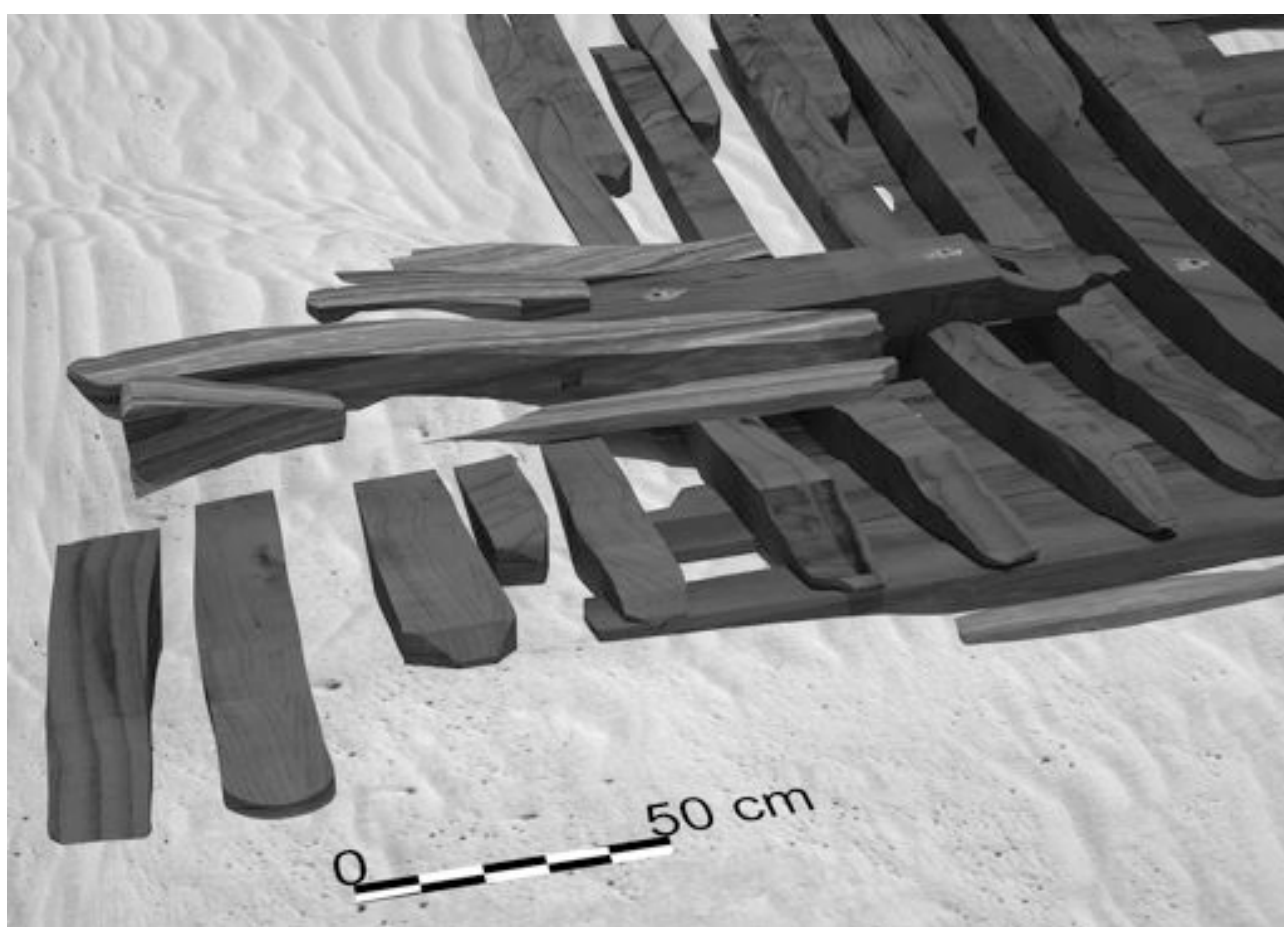
Fig. 2.18. Detail of longitudinal elements, keelson, mast step and cosce (drawing: E. Costa)

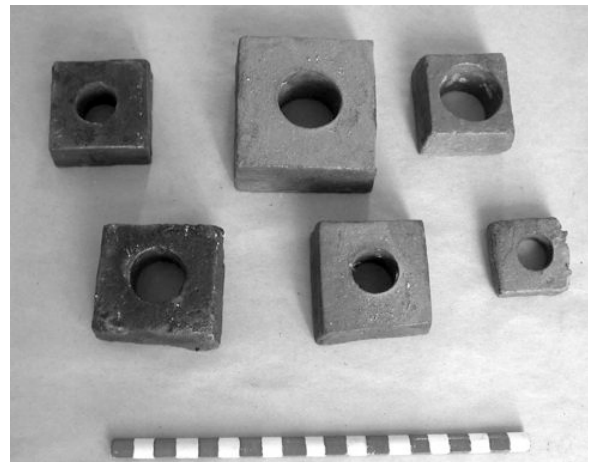
Fig. 3.21. Brass coaks of various sizes from wooden pulleys of blocks from the shipwreck of Gnalici (photo: the author)

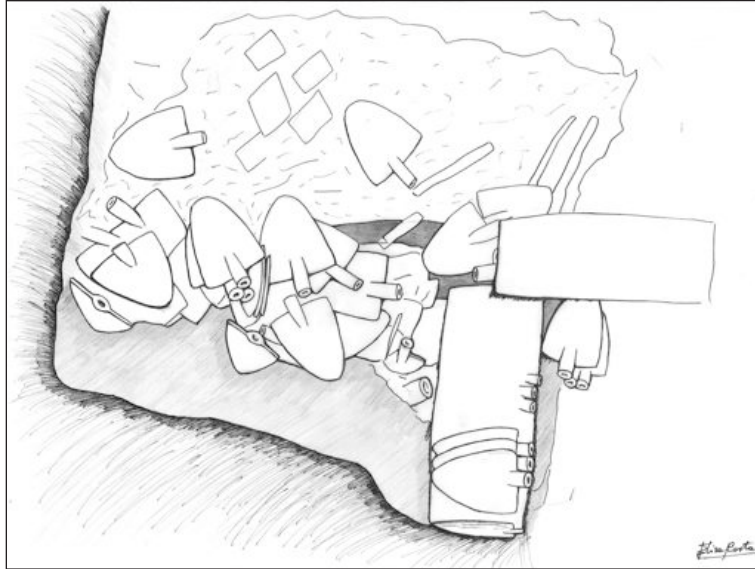
Fig. 3.32. Cluster of completely concreted iron shovels (drawing: E. Costa)

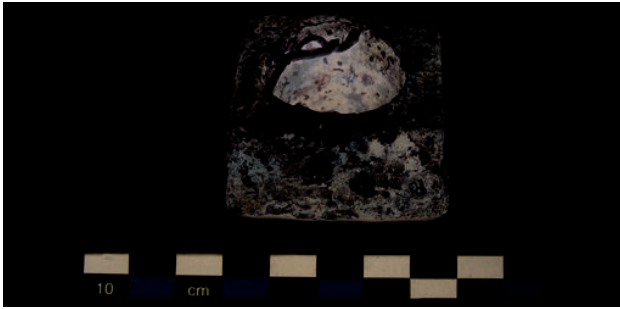
Fig. 4.12. Brass coak (photo: R. Mosković, HRZ archive)

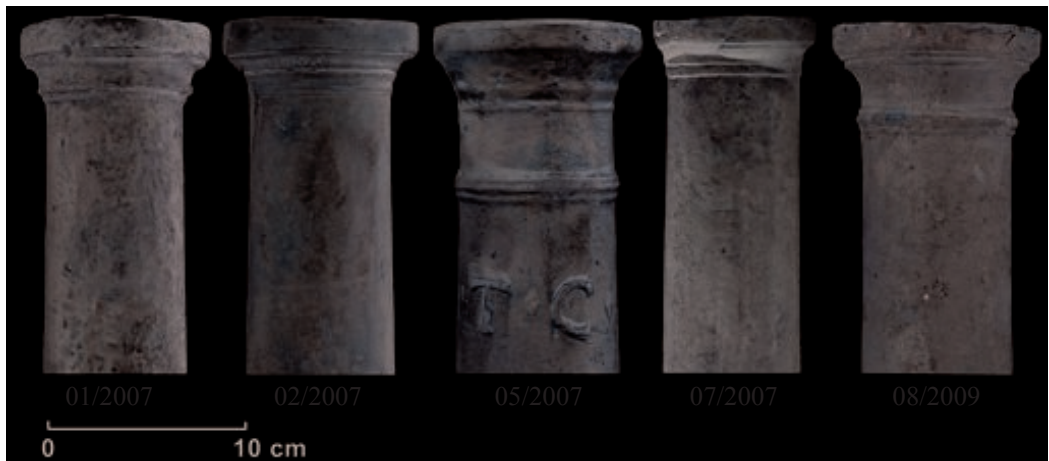
Fig. 4.36. (left) Breech of gun 08/2009 with signature of founder 'L F' (photo: R. Mosković, HRZ archive)

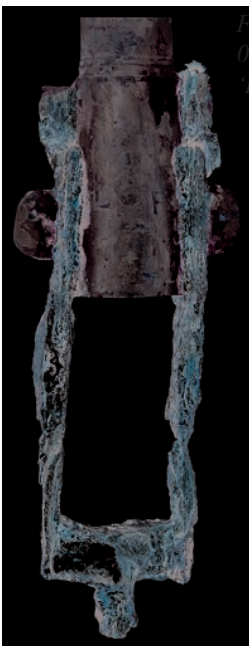
Fig. 4.37. Tampion used for closing the powder chamber of moschetto 05/2007 (photo: J. Macura, HRZ archive)

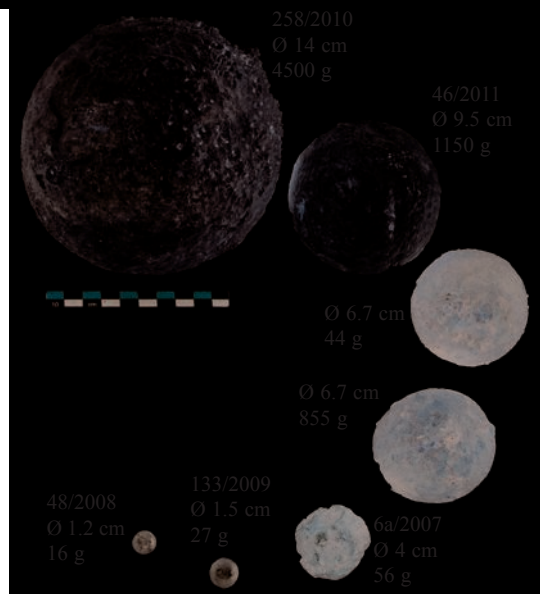
Fig. 4.40. Types of projectiles found on the Sv. Pavao site (photo: J. Macura, HRZ archive)

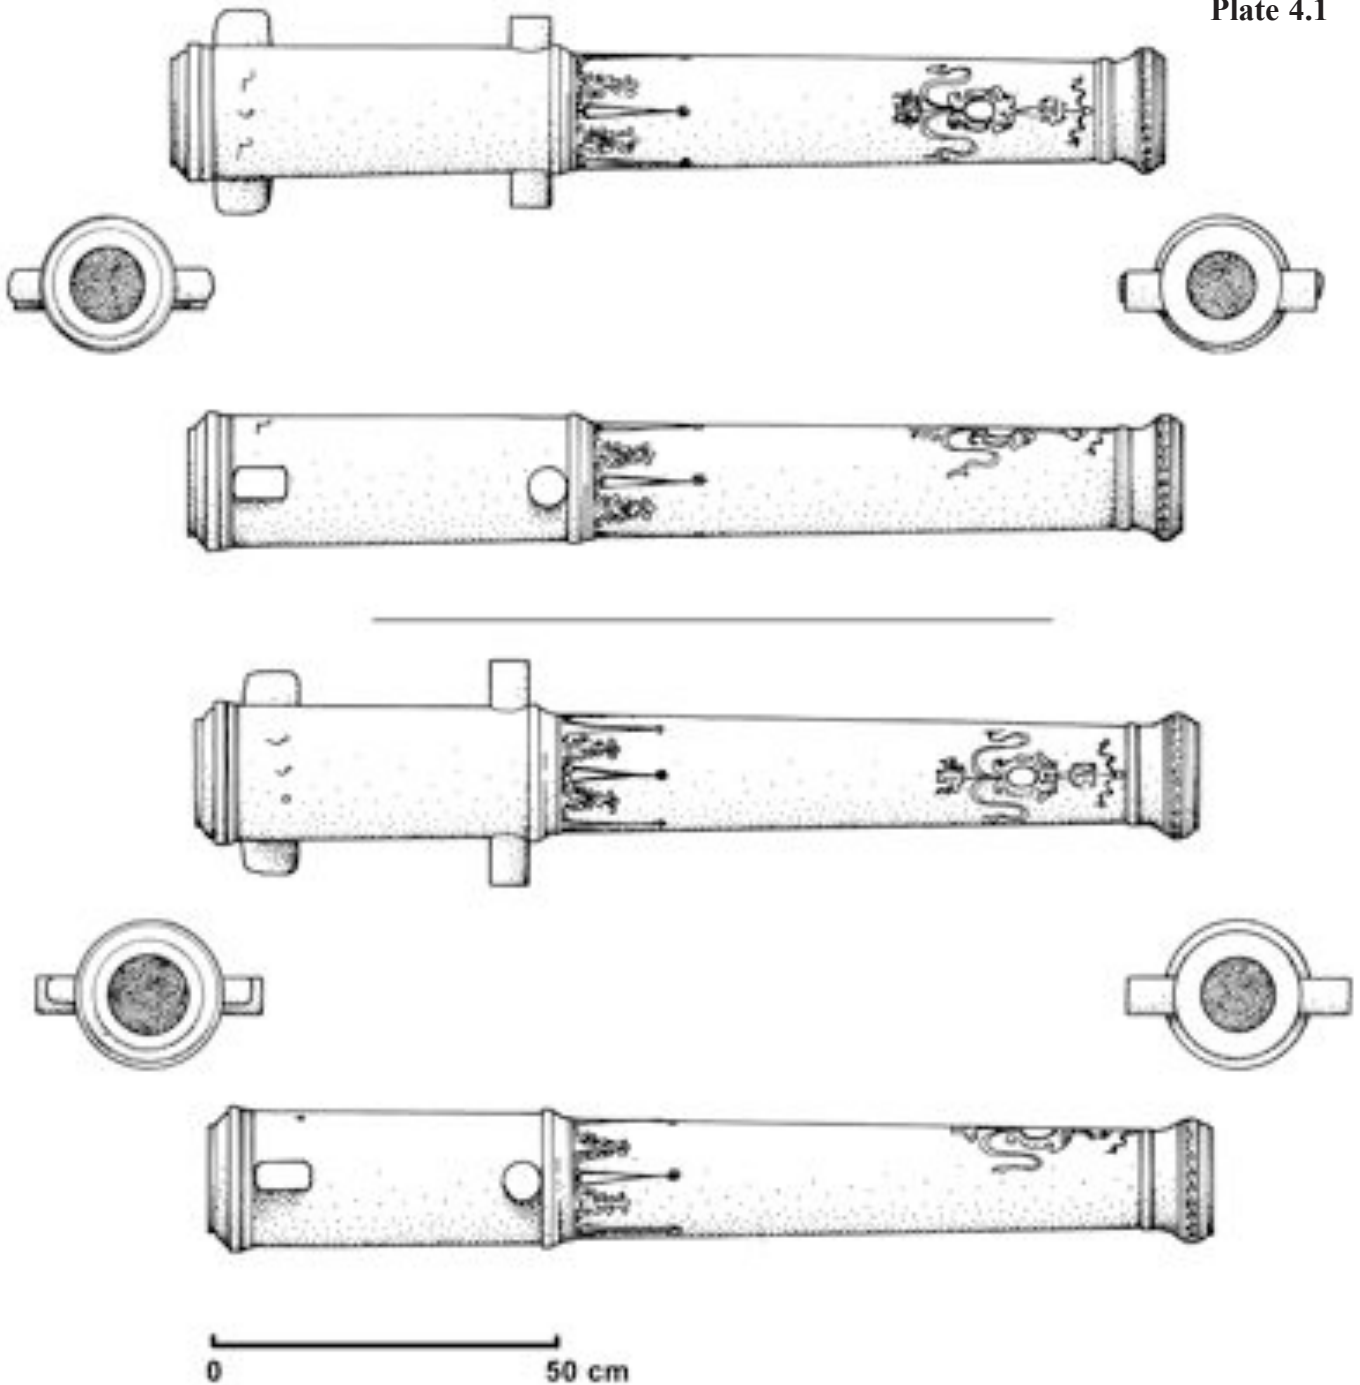
02/2007 (top)	03/2007 (above)
Length	145.5 cm	147 cm
Bore	10.7 cm	10.1 cm
Max. diameter at the muzzle mouldings	18 cm	18 cm
Diameter under the muzzle mouldings	13.6 cm	13.8 cm
Max. diameter at the breech	19.5 cm	20.5 cm
Trunnion diameter and length	5.8/5.5 cm	5.3/6.6 cm
Stamped weight	292	330
Weight	139 kg	156 kg

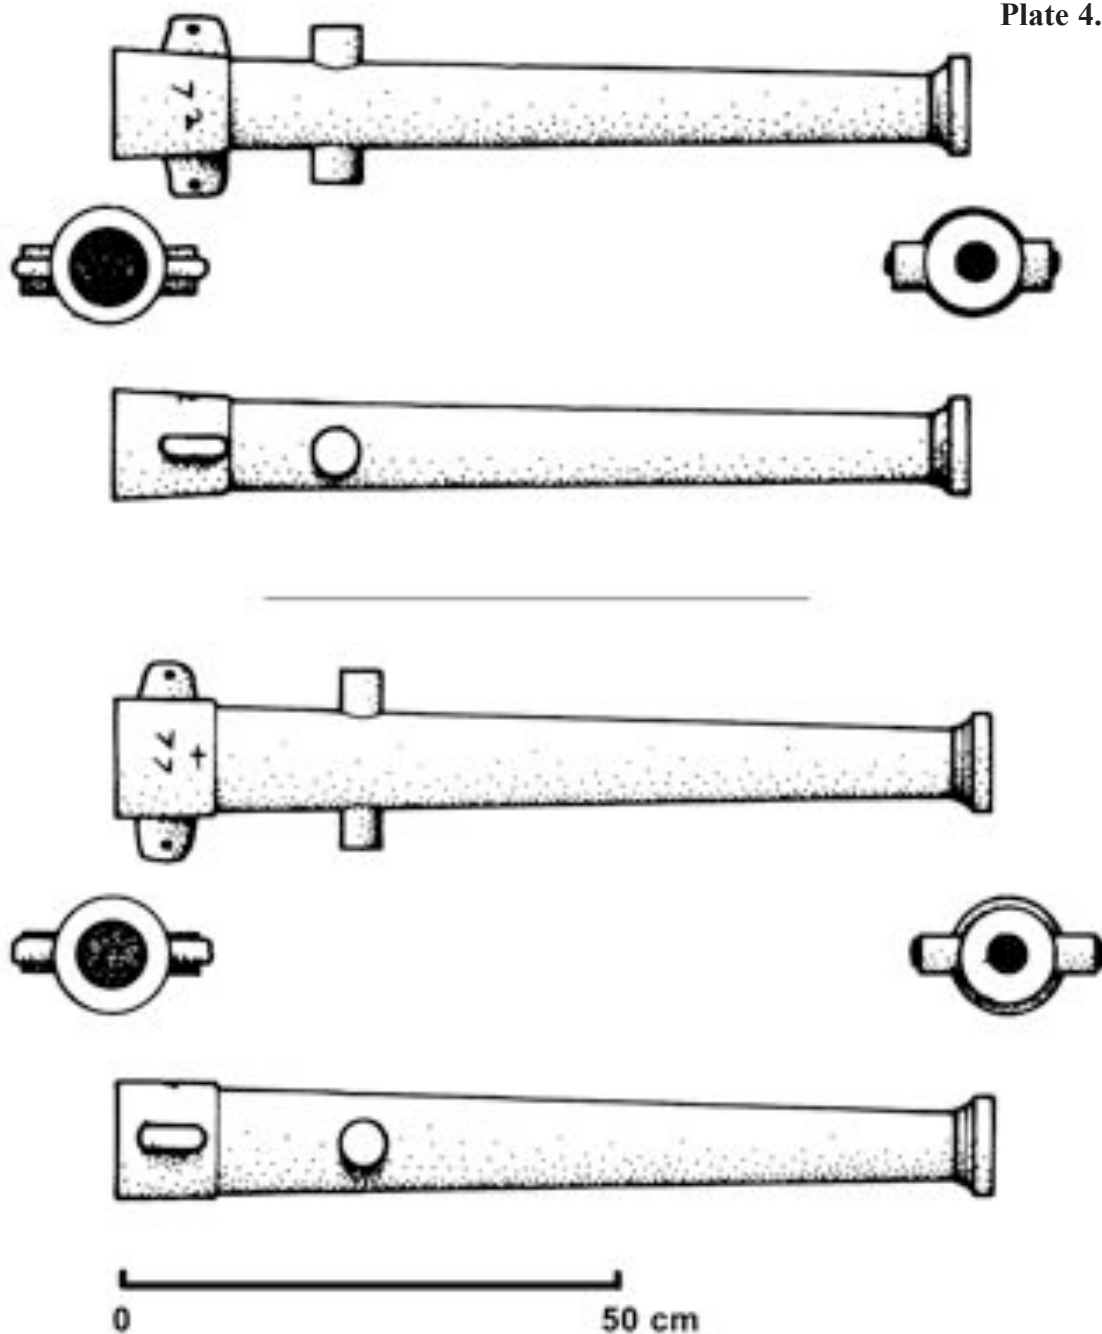
01/2007 (top)	04/2007 (above)
Length	87 cm	89 cm
Bore	4.3 cm	4.1 cm
Max. diameter at the muzzle mouldings	9.5 cm	9.9 cm
Diameter under the muzzle mouldings	6.9 cm	7.1 cm
Max. diameter at the breech	11 cm	12 cm
Trunnion diameter and length	5/3.5 cm	4/4.4 cm
Stamped weight	72	77
Weight	33.75 kg	37.4 kg

Pl. 4.2. Moschetti 01/2007 and 04/2007 (drawing: S. Zanetto)

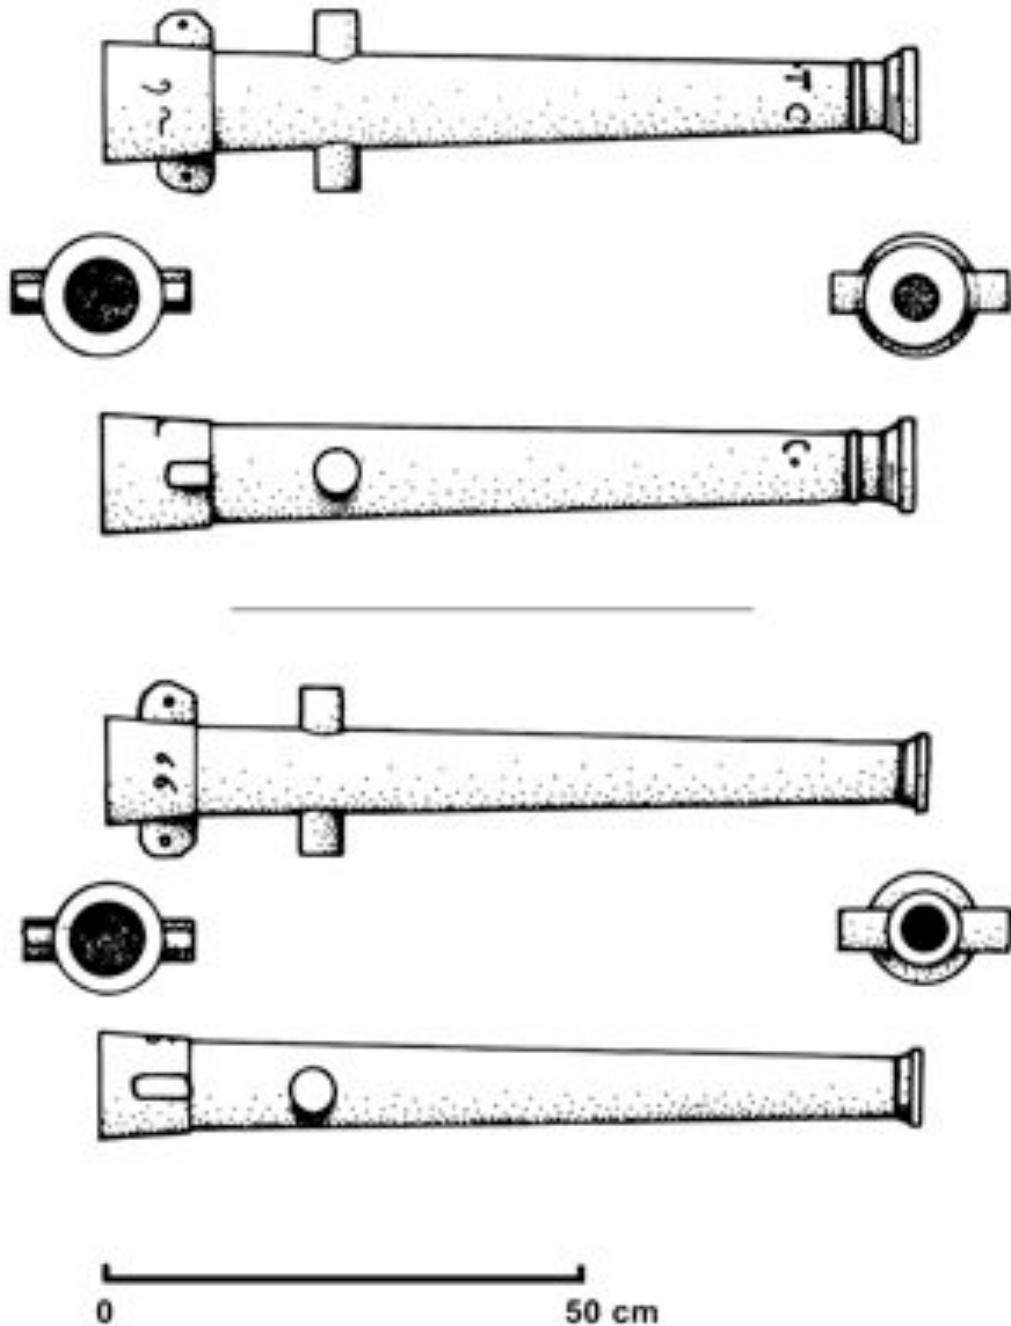
05/2007 (top)	07/2007 (above)
Length	86 cm	87 cm
Bore	4.1 cm	4.4 cm
Max. diameter at the muzzle mouldings	10.2 cm	8.3 cm
Diameter under the muzzle mouldings	7.5 cm	6.2 cm
Max. diameter at the breech	12.5 cm	11 cm
Trunnion diameter and length	4.5/4.5 cm	4.5/4.5 cm
Stamped weight	92	66
Weight	43.3 kg	31.8 kg
Signature	T C

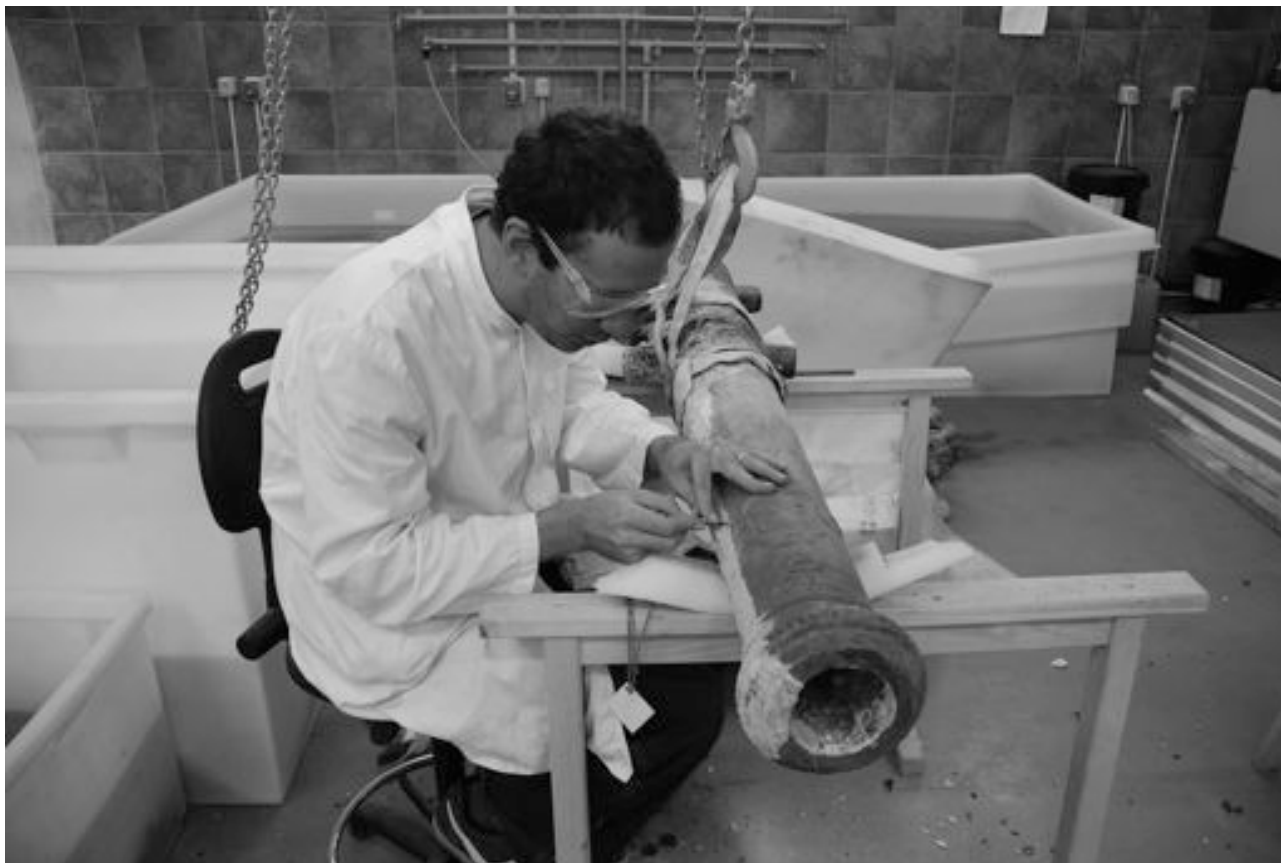
Fig. Appx1. Mechanical removal of sediment deposits from the barrel (photo: HRZ archive)
