# SUSTAINABILITY IN THE MAINTENANCE AND PROTECTION OF ARCHITECTURAL SURFACES: INNOVATIVE WATER-REPELLENT POZZOLANA-LIME MORTARS

## ABSTRACT

**Key-words:** Water-repellent admixtures, artificial weathering, salt crystallization, restoration mortars

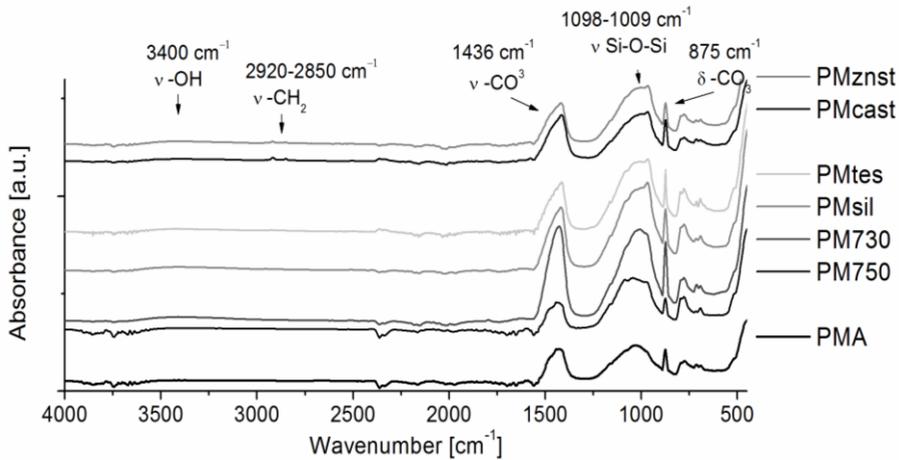
The FT-IR spectra of the mortars hardened for 28 days are shown in Fig. 2. The analyses revealed the presence of alumino-silicates (Si-O-Si stretching at 1098-

1009  $\text{cm}^{-1}$ ) due to the presence of t pozzolana and to the formation of calcium silicate hydrate (C-S-H) phases (C-S-H around 970  $\text{cm}^{-1}$ ). This second peak was observed particularly in the FT-IR spectra of PM750, PMtes, PMSil, PMcast, indicating a faster hydration. The peak was completely absent in PMznst denoting a slow hydration rate. The presence of calcium carbonates ( $\nu$   $-\text{CO}_3$  absorption at 1436  $\text{cm}^{-1}$ ) was observed, too. The samples collected from the surfaces of the specimens did not show the presence of  $\text{Ca}(\text{OH})_2$  ( $-\text{OH}$  stretching at 3640  $\text{cm}^{-1}$ ) which was, however, present in samples collected from the specimens bulk. Aliphatic  $-\text{CH}$  stretching absorptions were also visible at 2920-2850  $\text{cm}^{-1}$  in PMznst and PMcast and due to the addition of the stearates.

**Fig. 2** FT-IR spectra of mortars hardened for 28 days

These differences in the bulk density of the mortars are only partially reflected by their mechanical properties. The compressive strengths of the reference mortar PMA and of PMcast (Tab. 1) were both around 2.00 MPa with similar porosity. The use of Silres A® in PMsil resulted in a higher compressive strength (2.24 MPa), while with the other admixtures the strengths decreased, in particular for PMznst with zinc stearate. PMsil had probably a high hydration rate (as indicated also by the clear presence of C-S-H phases in the FT-IR spectra), which resulted in higher compressive strength even though the porosity was high. On the contrary, PMznst showed a slow formation of C-S-H phases (see also Fig. 2), which affected the mechanical properties.

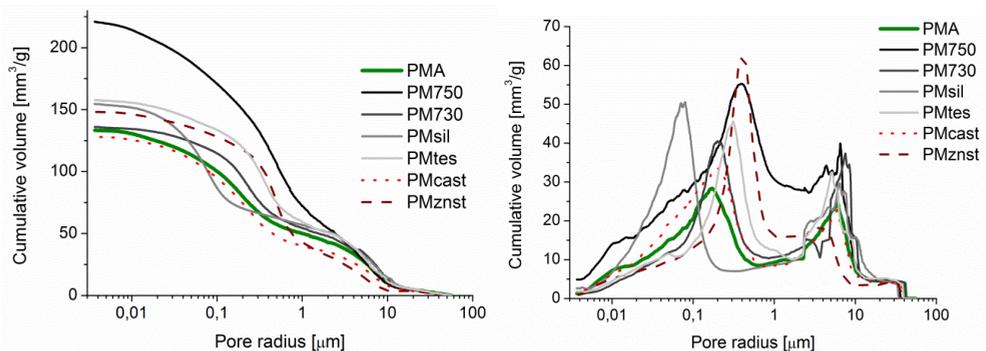
The total open porosity (Tab. 1 and Fig.3) was strongly influenced by the presence of water-repellent admixtures: the reference mix PMA had the highest bulk density and a total porosity around 25 %; The use of silane/siloxanes (PM750, PM730, PMsil, PMtes) resulted in the decrease of the density due to an increased porosity; the use of stearates did not change the porosity in comparison to PMA. A bimodal distribution of the pores sizes was observed: i) most frequent pore radii at 0.1  $\mu\text{m}$  and 9  $\mu\text{m}$  for PMA, PM730, PMcast; ii) most frequent pore radii at 0.3-0.4  $\mu\text{m}$  and 9  $\mu\text{m}$  for PM750, PMznst, PMtes, PMsil.

**Fig. 3-** Cumulative volume (left) and differential (right) pore size distribution of the mortar mixtures.

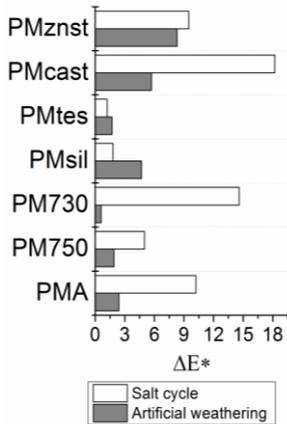
**Fig. 4-** Total colour variation  $\Delta E^*$  due to the different exposures

The artificial weathering caused moderate colour variations (Tab. 3, Fig. 4) with  $\Delta E$  up to 8.3 (PMznst). The colour variation, increment of a\* and b\* and decrease of L\*, was mainly due to the dissolution of the brighter external layer, rich in binder and the uncovering of darker aggregates. Slight colour variations were observed for PMA, P750, PMsil.

The specimens were characterized by coarse and non-homogeneous surfaces after the test and the colorimetric measurements (Tab.3 and Fig. 4) were affected by high standard deviation of the data.  $\Delta E$  values exceeded in most cases 5, considered a threshold value, beyond which the colour variation is clearly discernible to naked eye examination. A yellowing, reddening and darkening (increase of  $a^*$ ,  $b^*$  and decrease of  $L^*$ ) of the specimens occurred particularly evident for PMcast and PMznst.

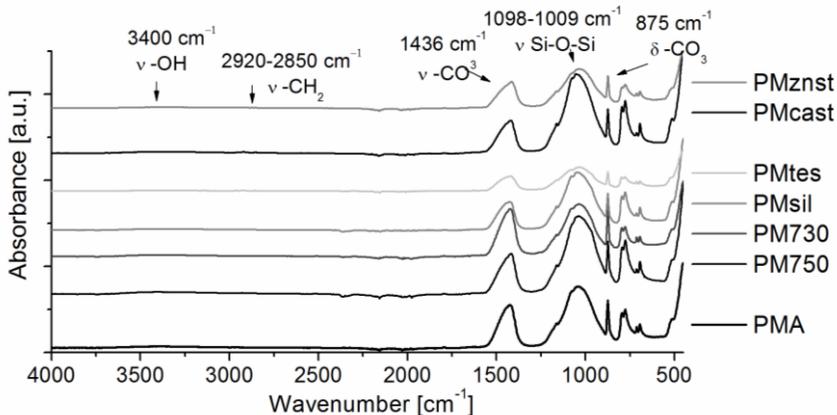
Carbonates and silicates were detected on the surfaces of the specimens after the weathering with FT-IR analyses (Fig. 5.). The shift of the Si-O-Si stretching absorption to around  $1000\text{ cm}^{-1}$  related to the production of C-S-H in every sample indicates further hydration of the binder in the hot and moist environment inside the climatic chamber. No calcium hydroxide was observed at the end of the exposure in the external layer up to a depth of 0.5 cm.

**Fig. 5** - FT-IR spectra of samples collected after the artificial ageing.

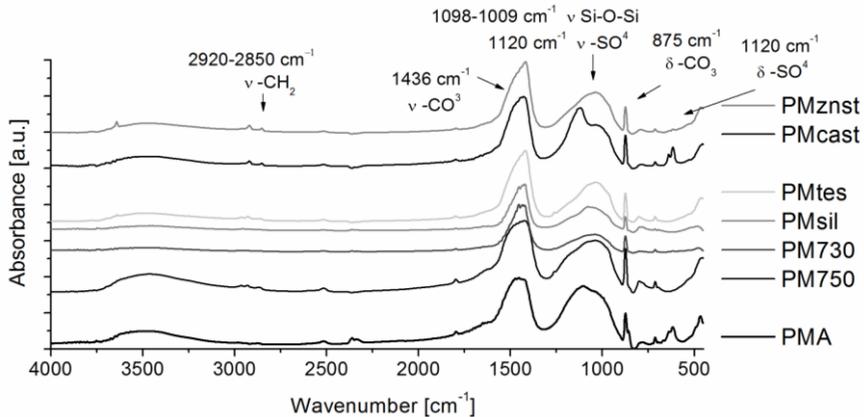
FT-IR analysis of samples collected after the cycles (Fig. 6.) showed, beyond the presence of silicates and carbonates, the presence of high quantities of sulphates in PMcast, PMznst, PMSil and PMA surfaces ( $-\text{SO}_4$  absorption at  $1120\text{ cm}^{-1}$ ), and lower absorption for PMtes, PM750, PM730. In PMznst and PMtes, calcium hydroxide ( $-\text{OH}$  absorptions at  $3640\text{ cm}^{-1}$ ) was detected.

**Fig. 6-** FT-IR spectra of samples collected after the salt cycles.
